SAFETY CASE REPORT

Doel 3

Reactor Pressure Vessel Assessment

5 December 2012

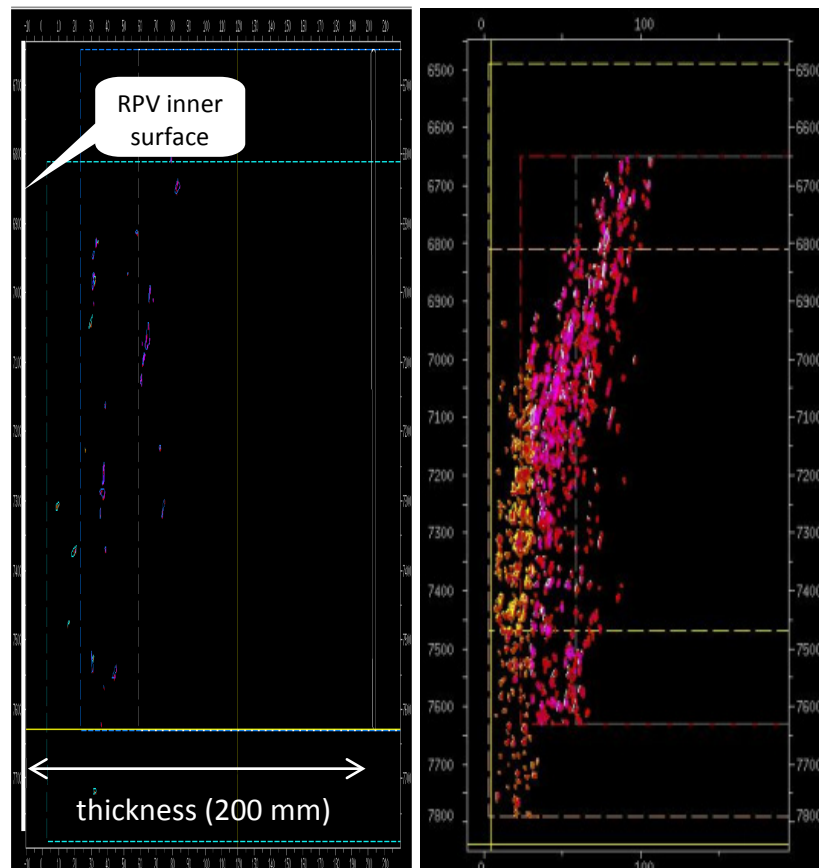
The figure below displays a typical example of data recorded in the lower core shell. Left: an axial section, with indications appearing as colour spots. Right: the indications, all detected in a 20° sector of the shell, are cumulated on the figure plane. They appear to be nearly laminar in nature and form a cluster sinking with increasing altitude, from the inner surface up to a depth of approximately 120 mm.

Figure 4.6 Indications recorded in the lower core shell of the Doel 3 RPV

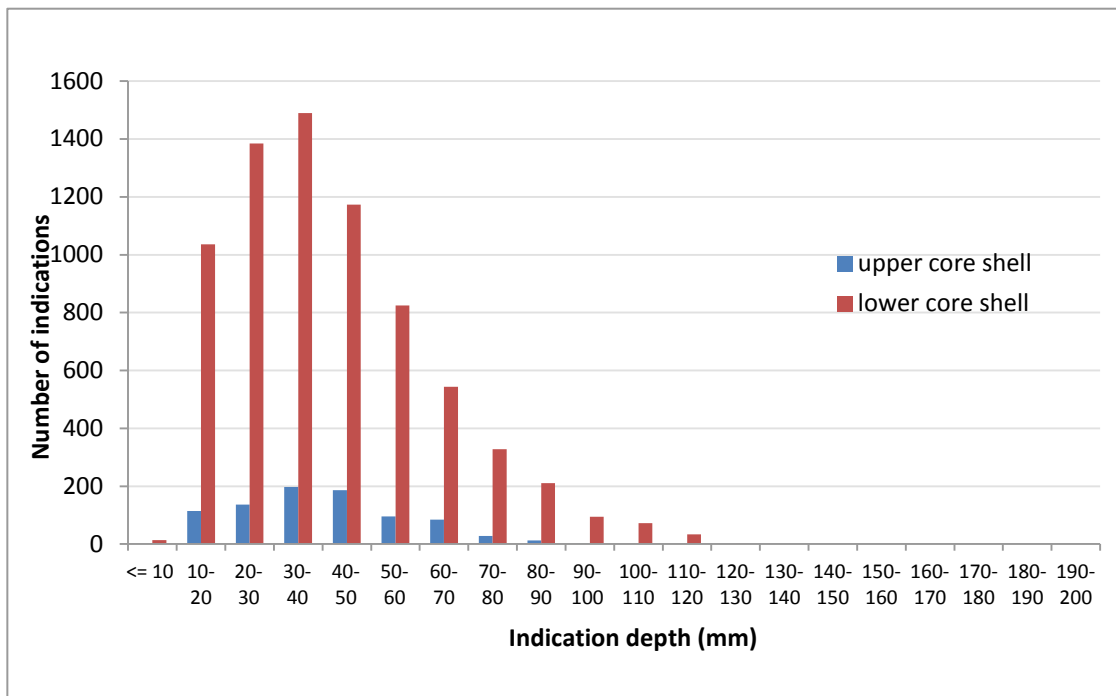
The figure below shows the distribution of indications as a function of depth (measured from the inner surface).

Figure 4.7 Distribution of indications as a function of depth

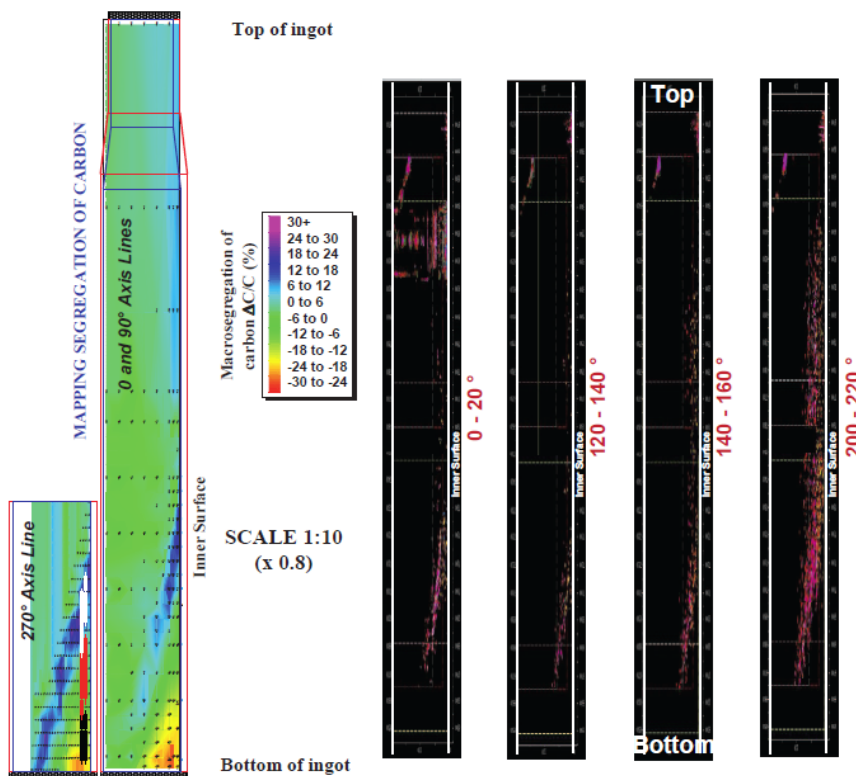
Figure 4.16 This figure shows a comparison with the profile of the indication envelope in the Doel 3 RPV

In the figure above, the shape of the distribution suggests that the positive macro-segregation has an influence on the mechanism by which the flaws are formed. The general shape of the envelope of the indications is similar in both the Doel 3 core shells and the Tihange 2 upper shell.

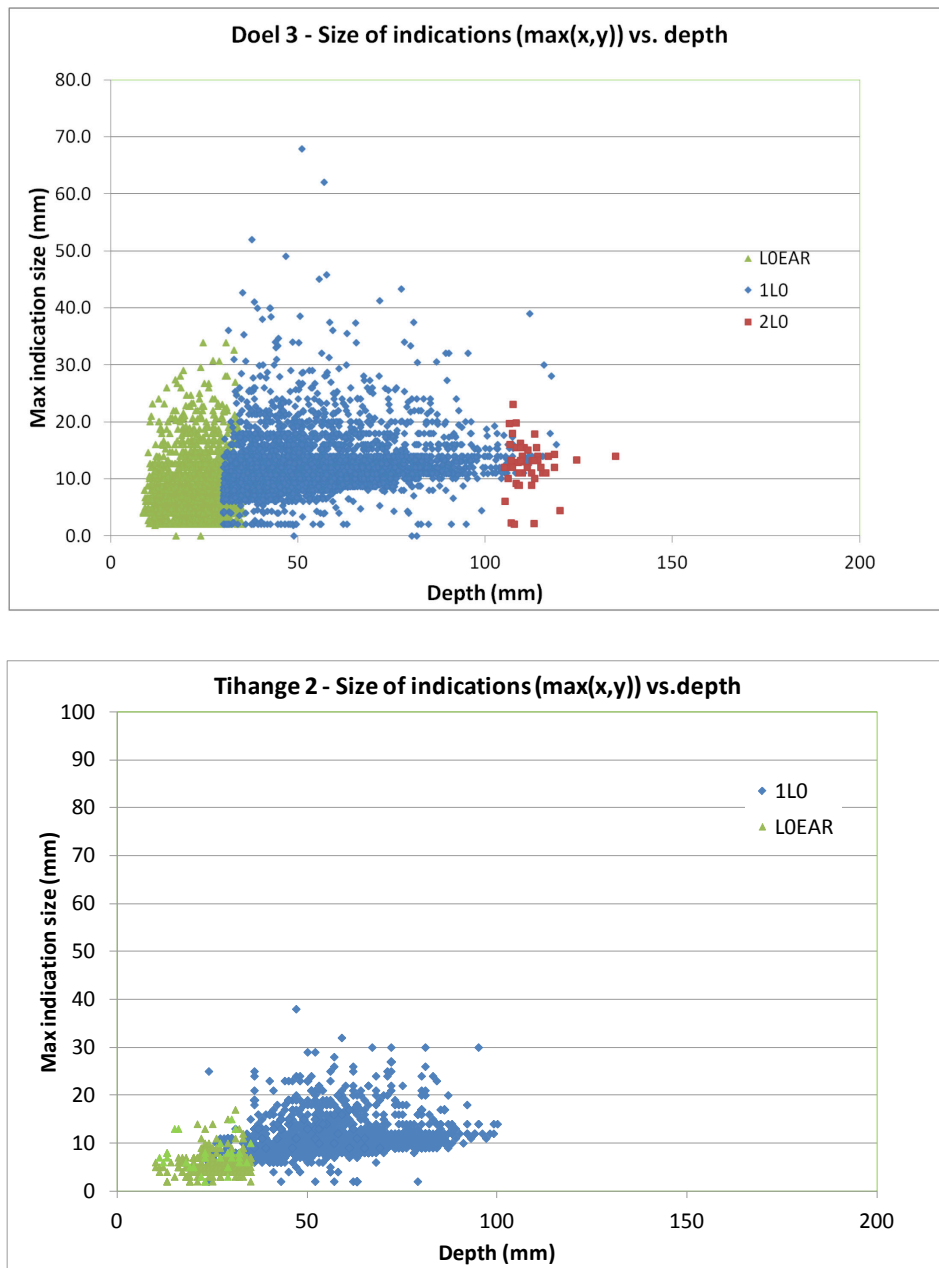
- There would be a concentration gradient of hydrogen from the inner to the outer surface, where no hydrogen is present. If this mechanism were active, hydrogen flakes should be larger in size close to the surface than any found deeper in the vessel. This has not proved to be the case. The largest indications are clearly not close to the surface but rather at a depth of 40 to 60 mm (see figures below).

Figure 4.21 Size of indications versus depth. The LO EAR, 1LO, and 2LO are the transducers used to inspect the different depth zones in the shell (7 to 35 mm, 30 to 125 mm, and 100 to 200 mm respectively, the distance being measured from the cladding inside surface).

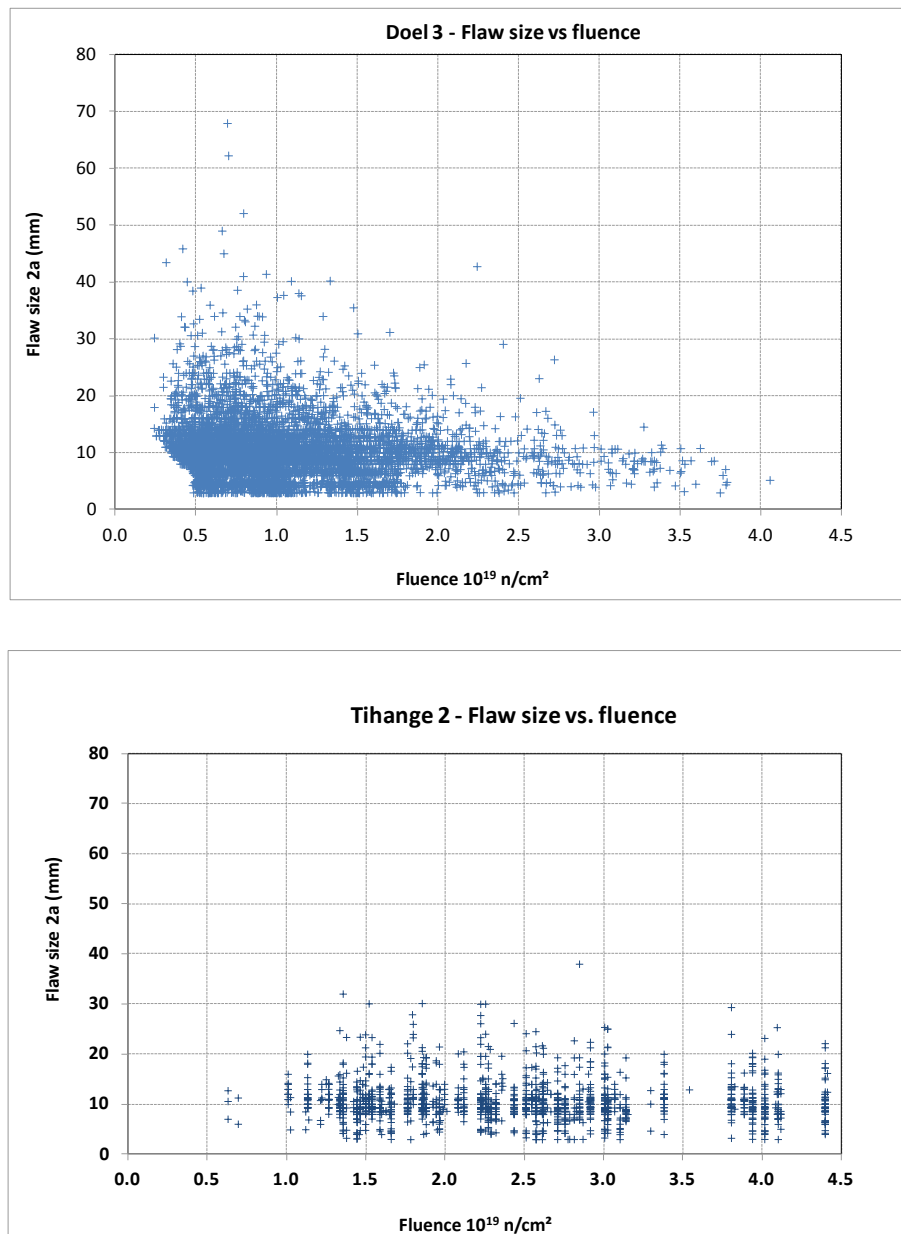
A 3D map of the neutron fluence (see sidebar)—radial, circumferential, and axial direction—is available and the specific fluence at the position of each indication is known. A plot of the indication size versus fluence should indicate a definite trend if irradiation induced a growth of the indications. The observed distribution confirms that there is no correlation between indication size and fluence (see figures below).

Figure 4.22 Distribution of flaw size versus fluence. The observed distribution confirms that there is no systematic increase in size of the indications with increasing fluence ($E > 1\text{MeV}$).

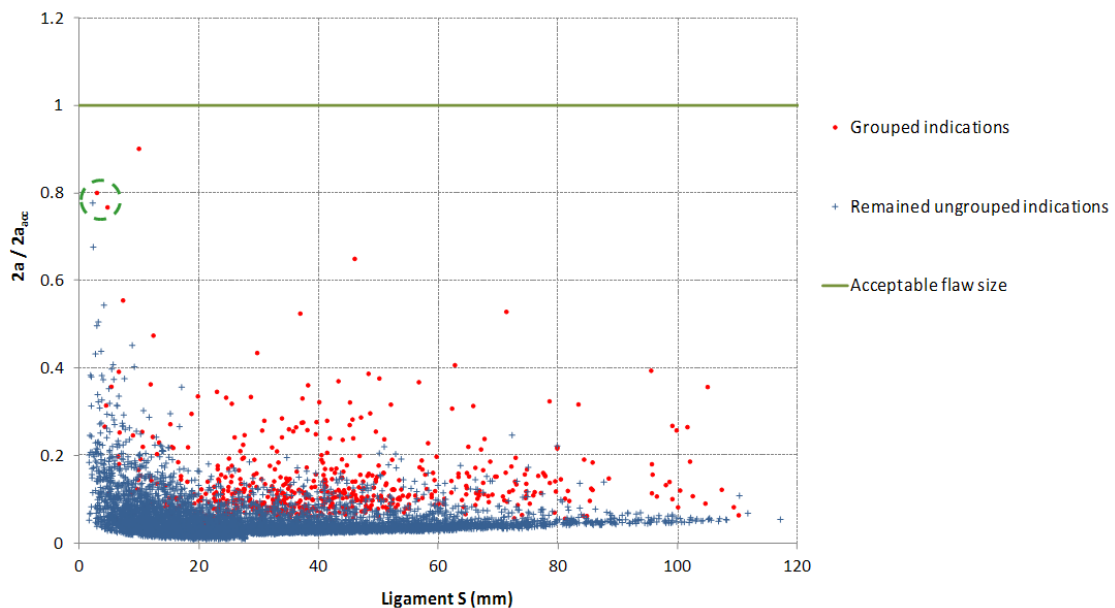
Figure 4.41 Comparison of actual flaw size to acceptable flaw size for lower core shell of Doel 3

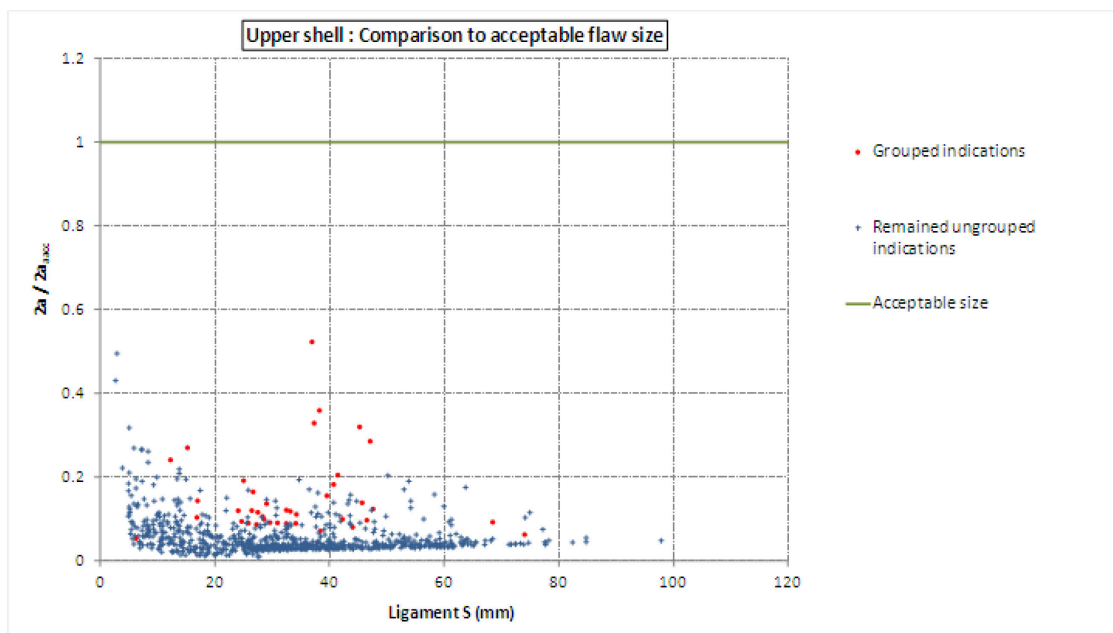
Figure 4.42 Comparison of actual flaw size to acceptable flaw size for upper core shell of Doel 3

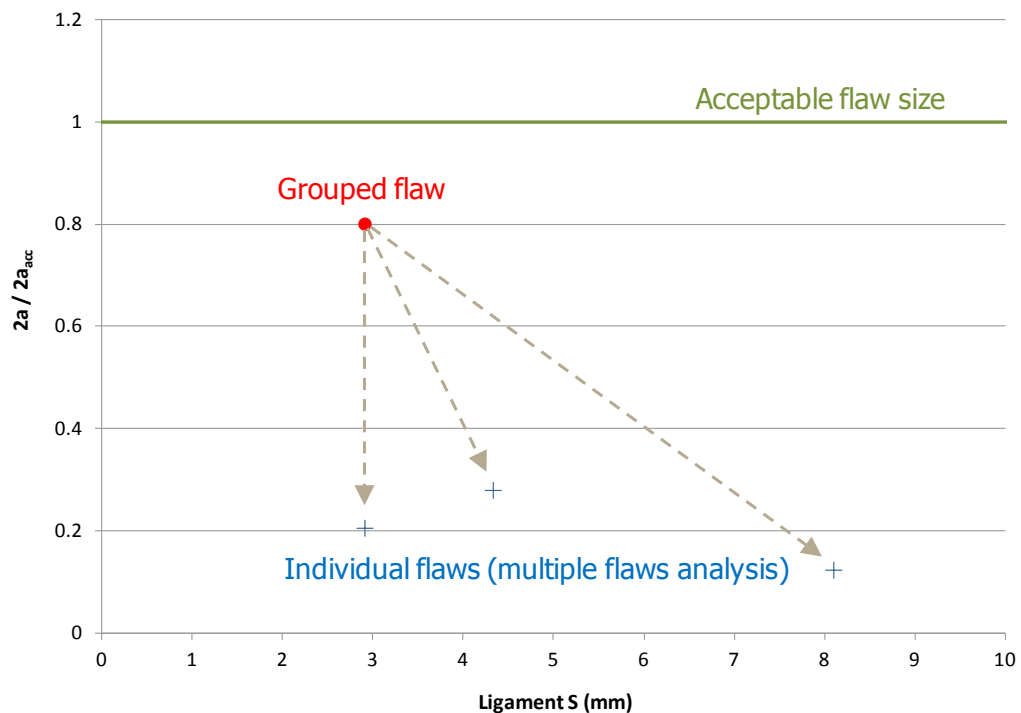
In order to assess the conservativeness of the grouping methodology, a number of grouped flaws were ungrouped, and a 3D Finite Element analysis was performed covering all individual flaws in the group and their mutual interactions. A typical result of such an analysis for one of the grouped flaws of the lower core shell is given in the figure below. The illustration below shows that the 20 % margin of the grouped flaw increases to more than 70 % when considering a 3D analysis of the multiple flaw configuration.

This **correction factor** was obtained by comparing two classical Stress Intensity Factor analyses performed according to Appendix A of ASME XI and based on a 2D Finite Element model of the entire RPV. In the first analysis the virtual conservative flaw was supposed to be located in the core shell, and in the second analysis in the transition ring or nozzle shell. As such, a correction factor of 1.48 was obtained for the transition ring, and 1.18 for the nozzle shell.

Figure 4.43 Comparison of grouped flaw versus multiple flaw analysis for the Doel 3 lower core shell
