SAFETY CASE 2015

# Tihange 2

## Reactor Pressure Vessel Assessment

28 10 2015

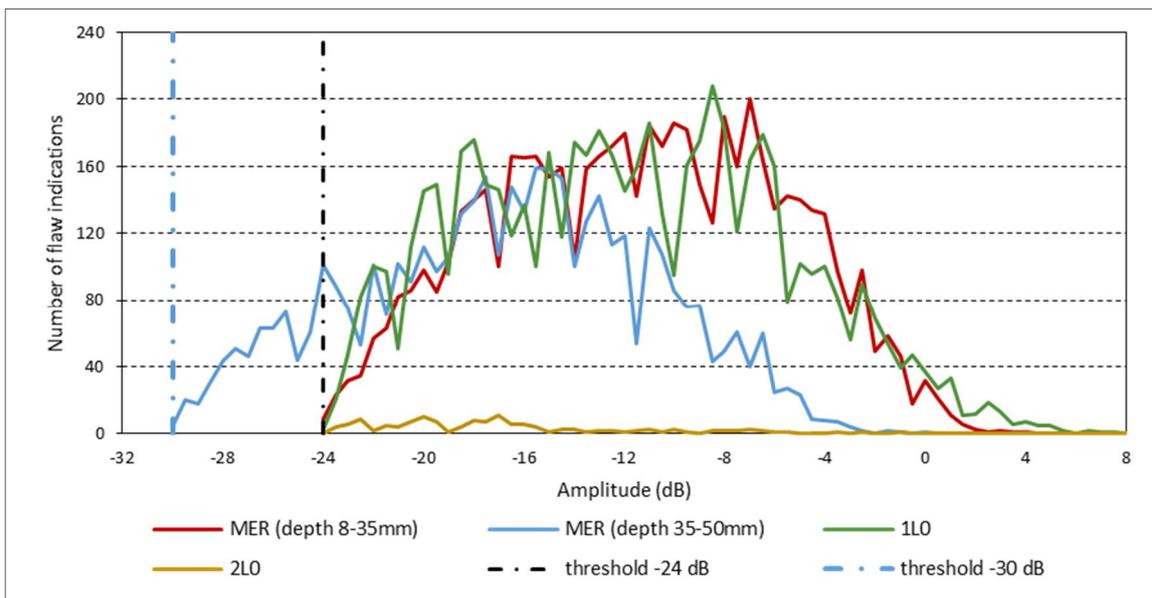
The full detection capability is further demonstrated by the vanishing left end of the amplitude distribution of each transducer at its reporting threshold (Figure 4.8).

Figure 4.8: Indication amplitude distribution (4 shells).

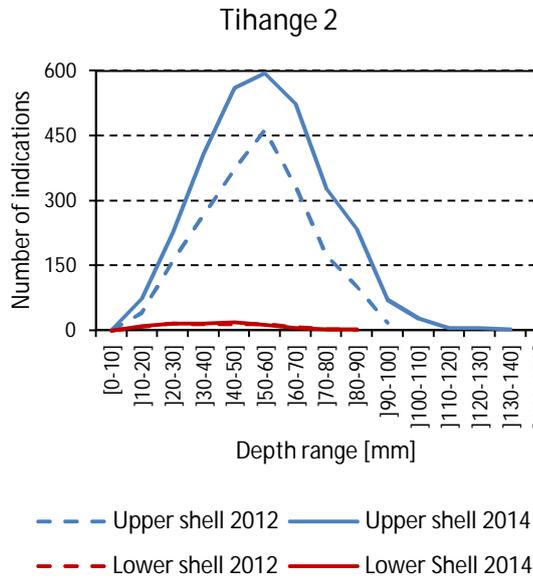
The 2012 inspection showed that the indications are not spread over the entire volume of the RPV shells. The 2014 re-inspection confirmed that the indications are located in those parts of the shells that were already known to contain flakes during the 2012 inspection (Figure 4.9).

Figure 4.9: Depth distribution of the indications in the RPV shells.

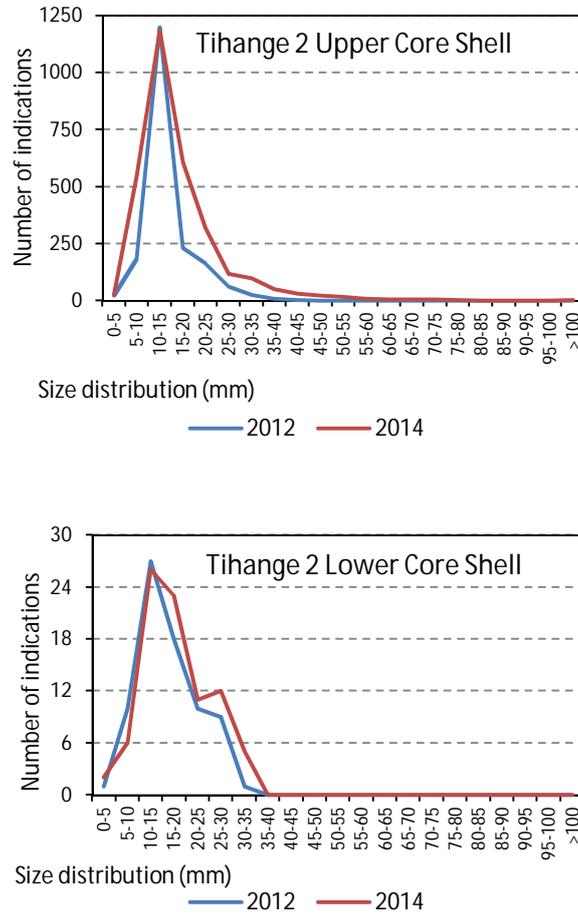
The re-inspection of the RPV shells revealed that the size distribution of the indications remained practically unchanged from 2012 to 2014 (Figure 4.11).

Figure 4.11: Indication size distribution in the Tihange 2 RPV shells.

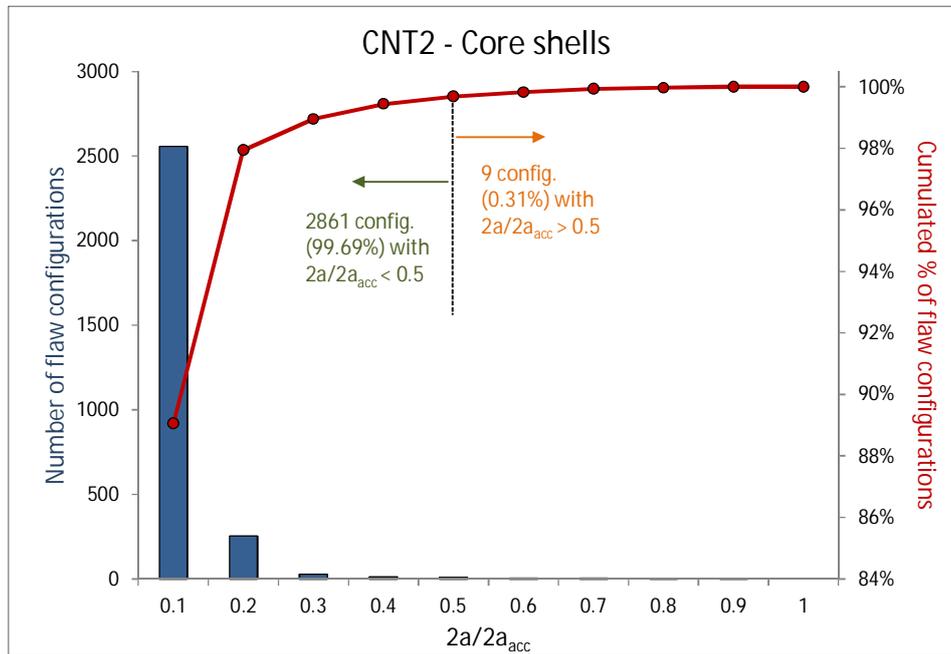
The few remaining flaw configurations that did not meet the screening criterion were subjected to a more refined analysis.

Figure 6.9: Flaw screening criterion applied to the core shells of Tihange 2-Histogram.

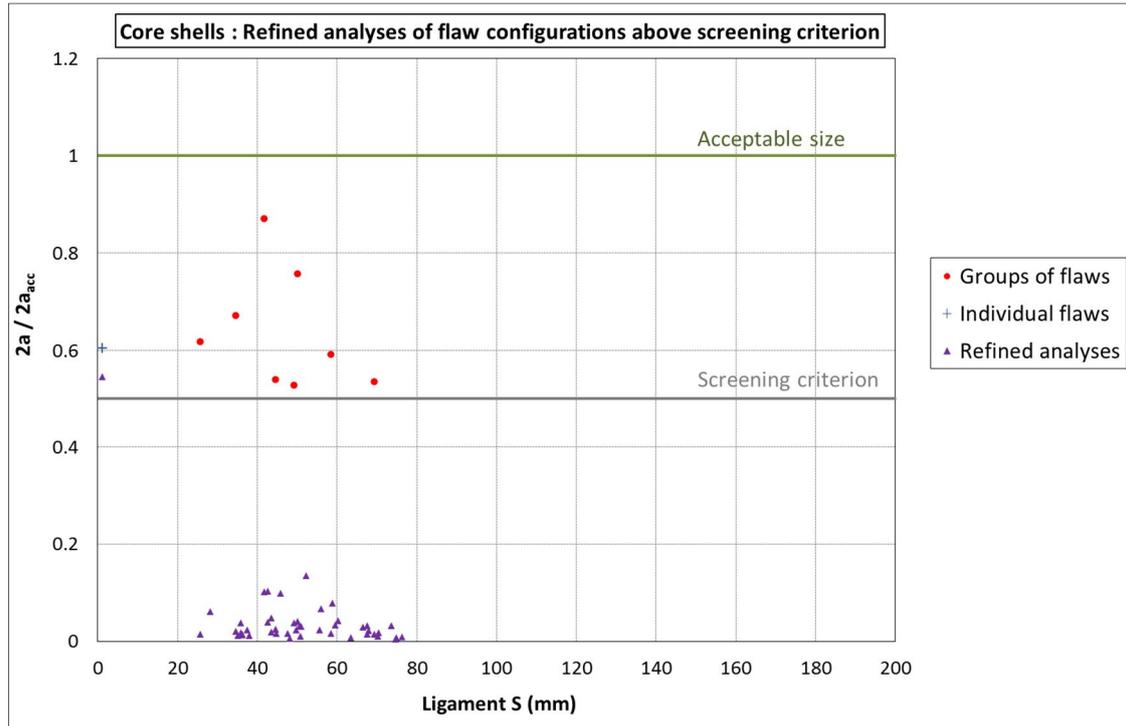
Figure 6.12: Comparison of core shell flaw configurations of Tihange 2 to acceptable size as a function of ligament after 3D refined analyses.

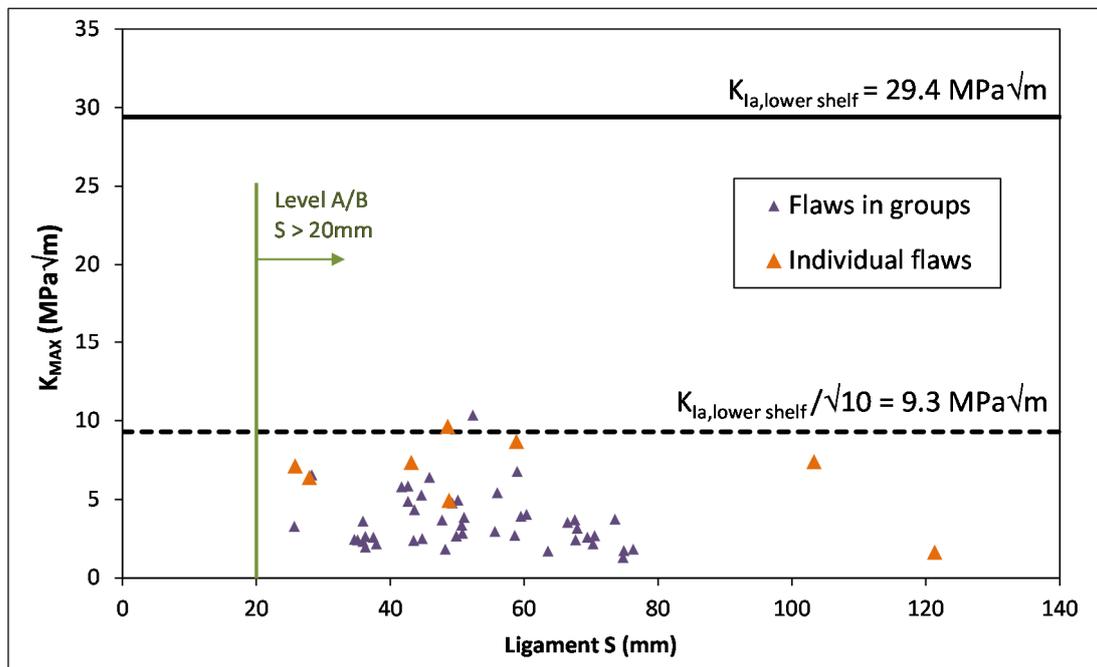
Figure 6.14:  $K_{MAX}$  values compared to lower shelf toughness for flaws far from the cladding-base metal interface (Tihange 2 RPV).

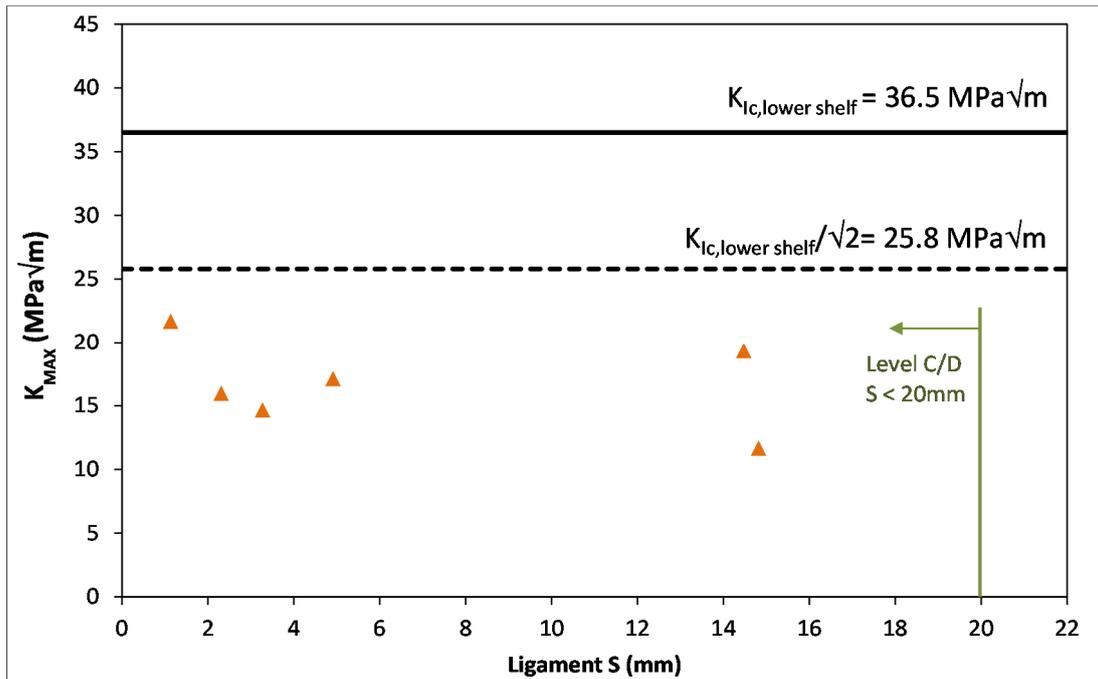
Figure 6.15:  $K_{MAX}$  values compared to lower shelf toughness for flaws close to the cladding-base metal interface (Tihange 2 RPV).
