Doel 3 and Tihange 2 reactor pressure vessels Provisional evaluation report

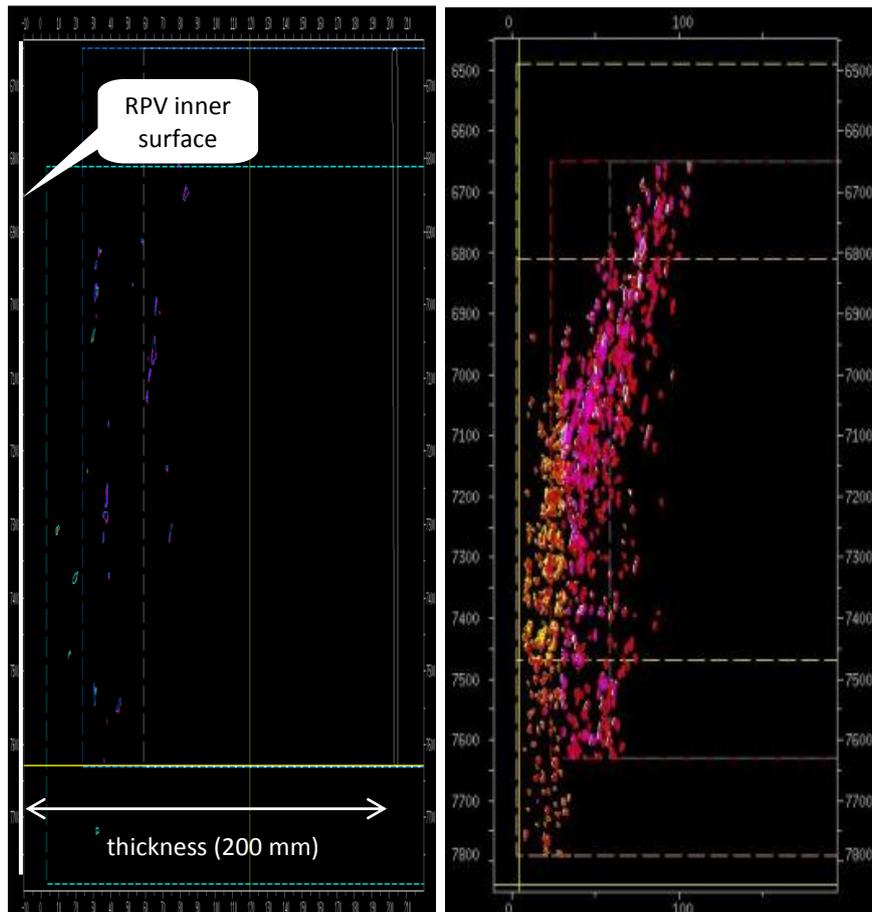
Figure 4 – Indications recorded in the lower core shell of the Doel 3 reactor pressure vessel

The first round of in-service inspections of the Doel 3 reactor pressure vessel conducted in late June 2012 found no underclad defects. However, it resulted in the detection of a high number of indications in the base steel of the reactor pressure vessel, more precisely in the lower core shell of the vessel.

In both core shells, the laminar flaws form a cluster in the central strip of the shell, which ranges in depth from the stainless steel clad interface up to 120 mm. The indications measure on average 10-14 mm in diameter (with some even exceeding 20-25 mm).

Figure 4 below displays a typical example of data recorded in the lower core shell. Left: an axial section, with indications appearing as colour spots. Right: the indications, all detected in a 20° sector of the shell, are cumulated on the figure plane (333 sections).
