**REPORT ON INDEPENDENT
ANALYSIS AND ADVICE
REGARDING THE SAFETY CASE**

Doel 3

Reactor Pressure Vessel Assessment

Electrabel
GDF SUEZ

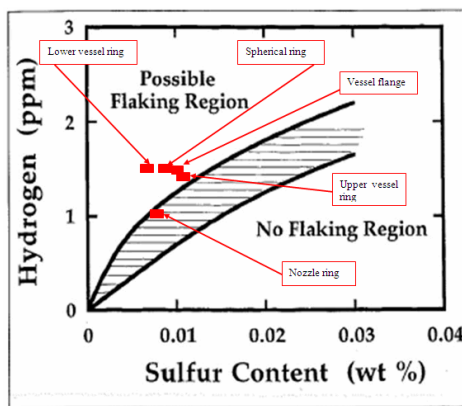
The following chart illustrates the above statement specifically regarding the influence of the concentration of sulphur—one of the most important chemical parameters for hydrogen flaking—in the forged pieces of the Doel 3 RPV (the actual amount of sulphur measured by Krupp is lower than the specified value of 0.02 wt%). This led AREVA (in the 1980's) to specify a maximum hydrogen concentration of 0.8 ppm to avoid the risk of hydrogen flaking.

Although the chart above (R. J. Fruehan, *Iron & Steelmaker*, 1997)—adapted to the specificities of the Doel 3 RPV—is mainly indicative, both the upper and lower shells of the Doel 3 RPV shell are in the possible flaking region. The lower shell of the Doel 3 RPV, which is most affected by flakes, appears in the deepest part of this region.

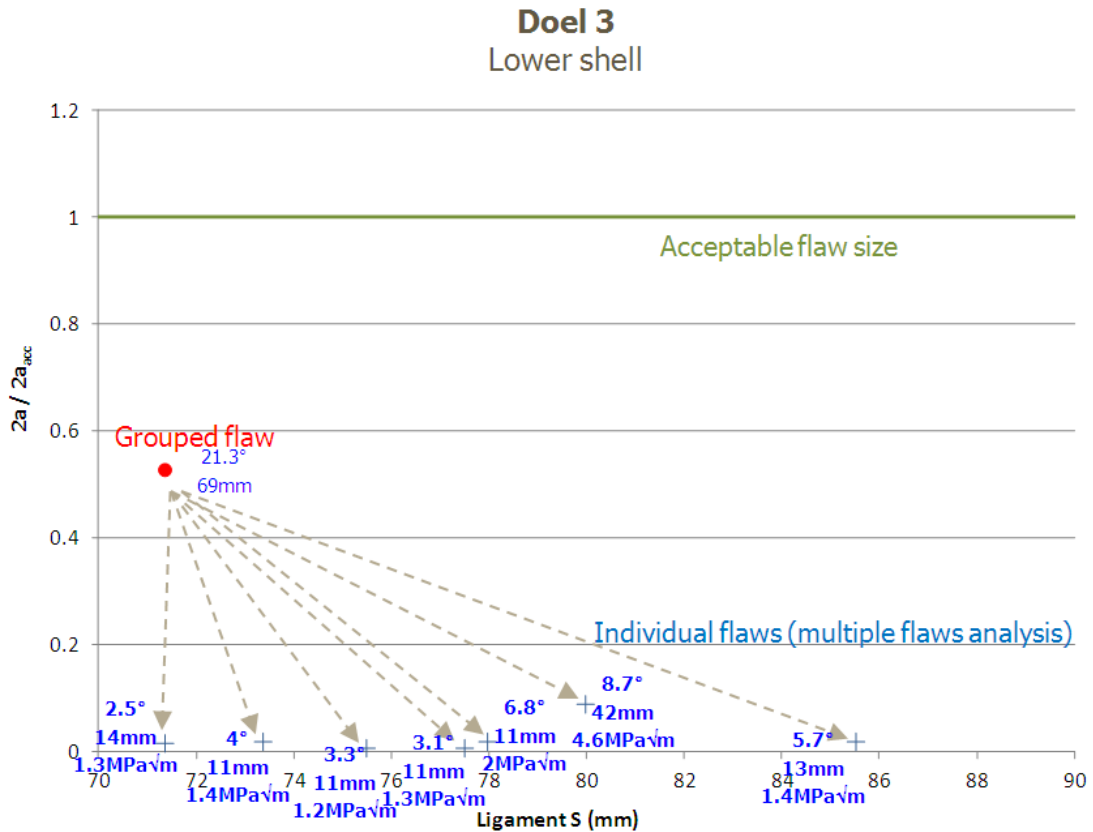
SNL has demonstrated that the grouping procedure can underestimate the equivalent stress intensity factor. Therefore, SNL asked the Project Team to reassess its grouping methodology. SNL recommended that all grouped flaws deemed acceptable using the grouping methodology developed by the Project Team be reassessed. In response, the Project Team has confirmed the global conservativeness of its grouping method through detailed multi-flaw analyses performed for Doel 3 of:

- The three groups closest to the cladding in the elastic-plastic zone and closest to the maximum allowable size before facing a crack initiation risk (see picture in Chapter 4.5.2).
- A group containing a large number of flaws (7) in the linear elastic zone.

The results of such 3D calculations for the 7 ungrouped flaws show a significant increase of the margin with respect to the maximum allowable size.

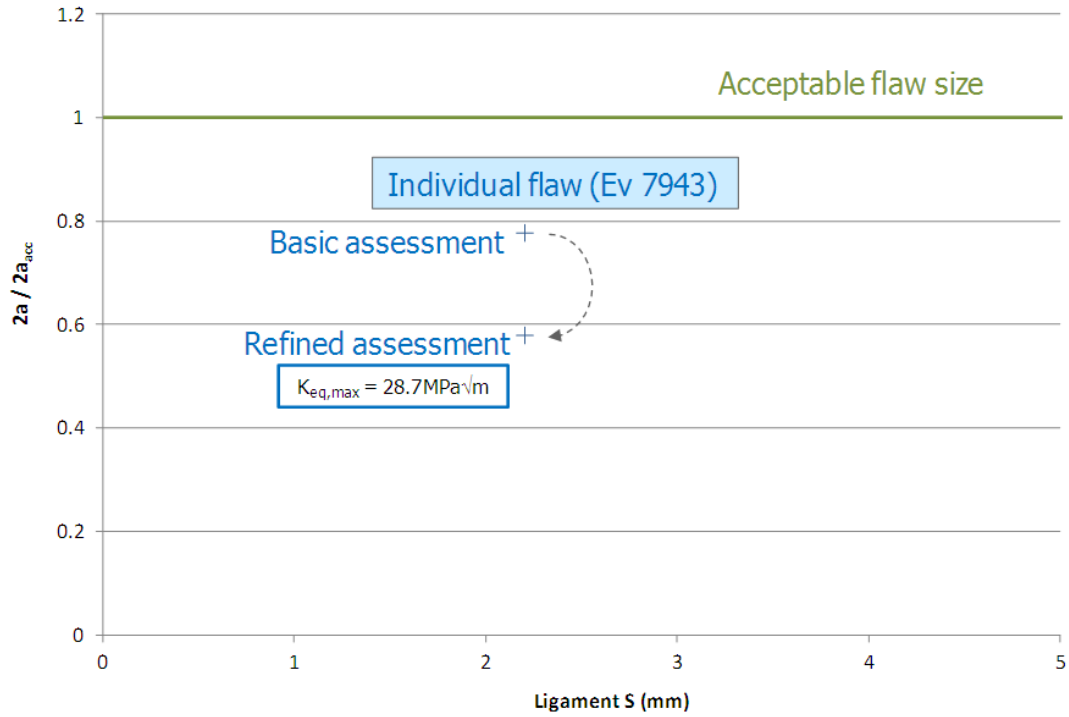
SNL has shown that considering such flaws in isolation can be non-conservative for some configurations of closely-spaced flaws. SNL recommended that flaws that have been deemed acceptable in isolation by the Project Team be reassessed in light of the effect that neighbouring flaws may have on them. In order to address this concern, the Project Team assessed the influence of the environment on ungrouped flaws through 3D analysis of the two individual flaws closest to the maximum available size. One result is shown in the picture below where the refined assessment shows a significant additional margin:

In light of the results, SNL concludes that the Project Team approach is reasonable and that it will ensure the adequacy of the methodology. The SCP Review Team agrees with this conclusion.

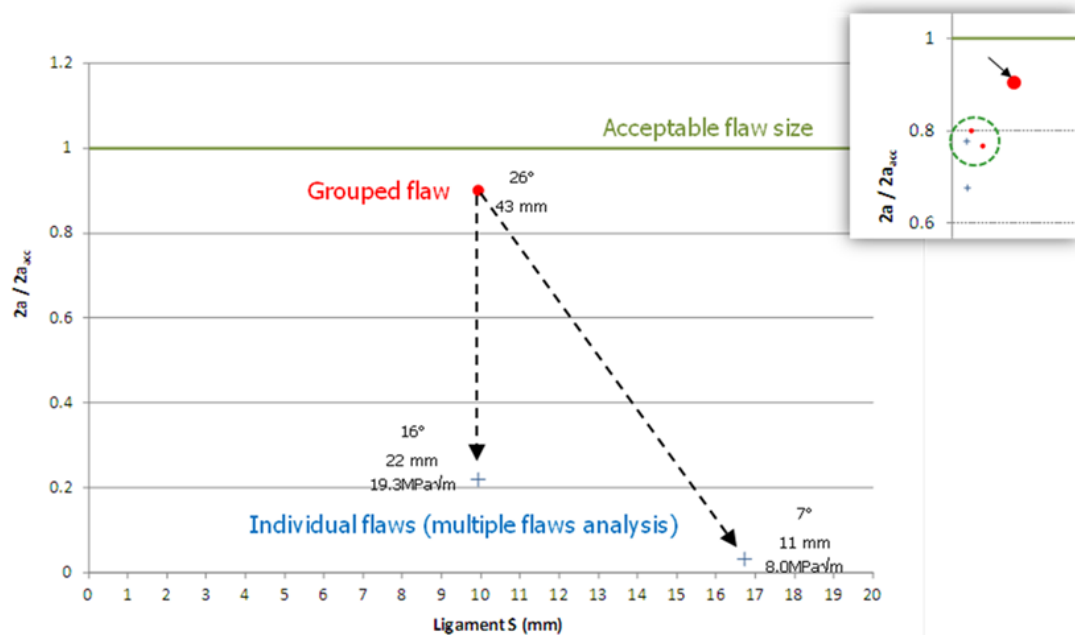
The Project Team has clearly demonstrated that the only cases for which this question was relevant were acceptable. The relevant cases are the ones in which the flaws (grouped or isolated) are close to the maximum allowable size before facing a crack initiation risk, according to the ASME values. For the flaws close to this limit value, calculations have been made by the Project Team to quantify the impact of the grouping criteria and the surrounding flaws. To perform those calculations, the grouped flaws have been un-grouped. The set of un-grouped flaws has been evaluated through 3D calculations. The results were completely satisfactory, showing that the grouping criteria used were acceptable and offered a large margin versus allowable size, as shown in the graph below.

Similar 3D calculations were performed for the most critical isolated flaw, with similar results. The potential lack of conservativeness due to the neglected influence of the surrounding flaws on the calculated flaw, was largely compensated for by the over-conservativeness of the flaw grouping methodology.

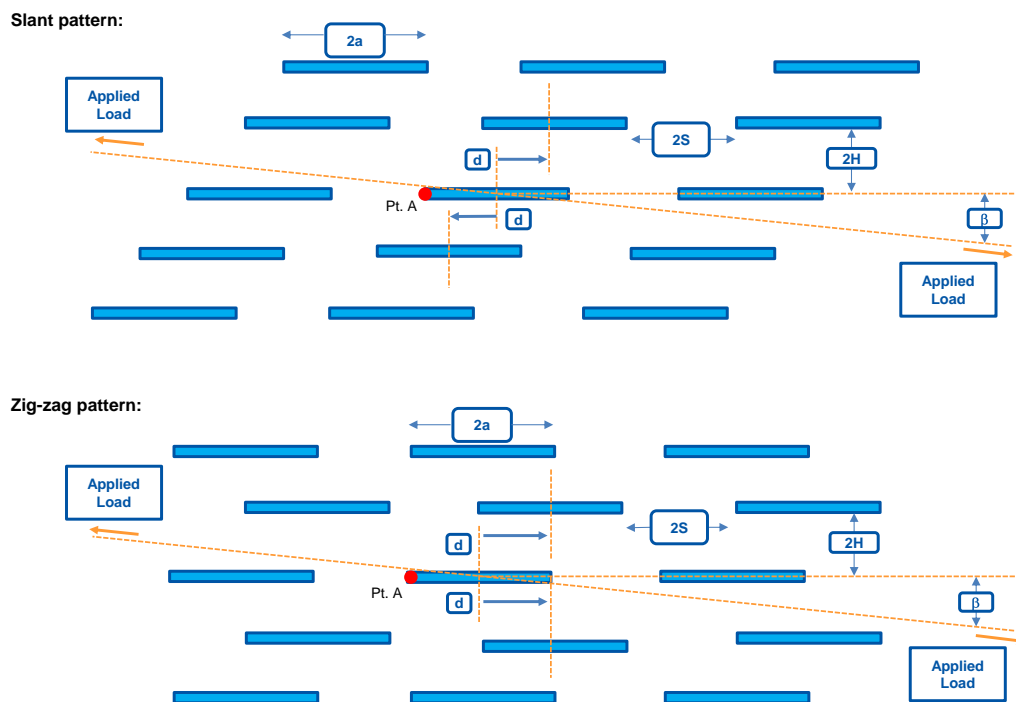
Two-dimensional analyses involving a group of equally-sized, uniformly-spaced planar circular flaws were performed by SNL to investigate the role of flaw configuration and spacing on fracture criticality, as well as to identify the more penalizing flaw configurations for the three-dimensional finite element analyses.

A group of 5 by 5 (25 in total) equally-sized flaws in various configurations was assessed. Two flaw patterns were investigated, slant and zig-zag (see Figure above). Four intra-row (within a single row) flaw spacings (S/a) were investigated: 0.5, 1.0, 1.5, and 2.0. For each intra-row spacing several inter-row shifts (d/a) were investigated that span the entire range of possible shifts.
