SAFETY CASE REPORT

Doel 3

Reactor Pressure Vessel Assessment

5 December 2012

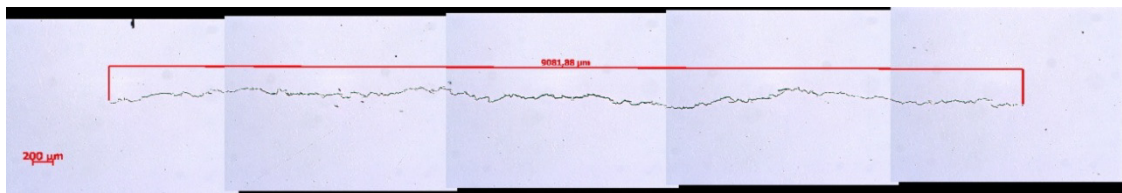
Figure 4.11 Profile of a cut indication in the VB395/1 specimen (9,081.88 μm)

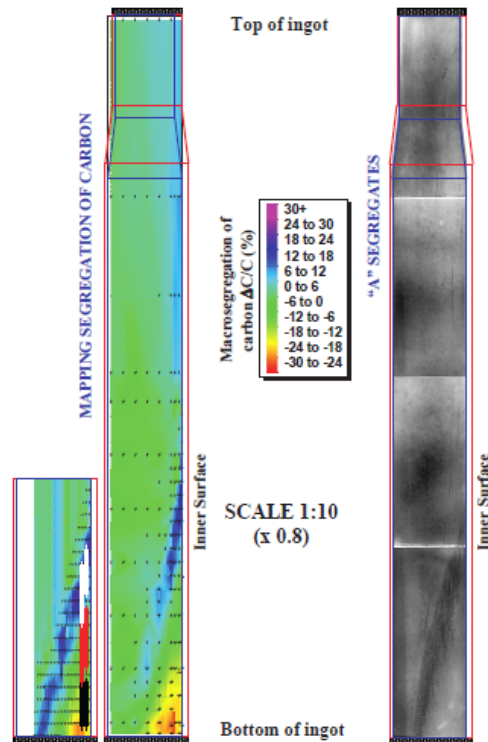
A clear link was established between the indication distribution profile in the component and the expected positive macro-segregation profile. This expected profile is based on an extensive research program performed by AREVA in the 1990s.

Figure 4.15 Metallurgical features revealed in a forged shell (right) and result from carbon mapping (left)

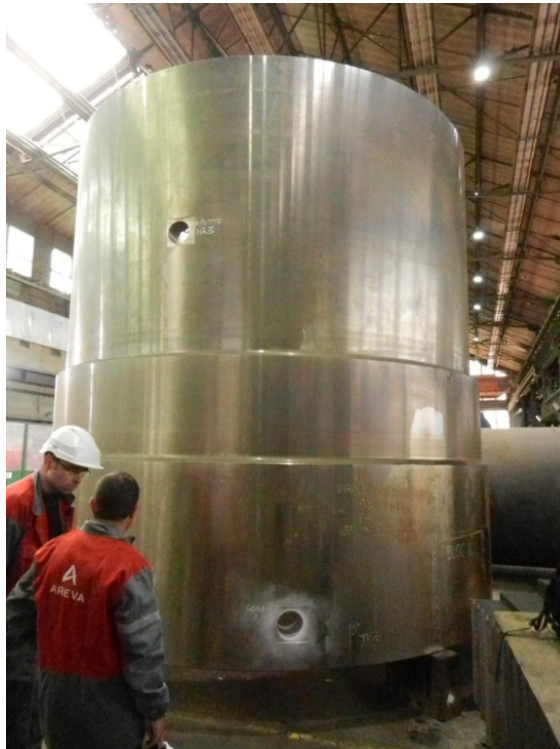
In 2011, a forged shell, identified as VB395, meant for a 1,300 MW plant steam generator, was rejected at AREVA (France) because of hydrogen flaking. As a result of a loss of reliability of the hydrogen measurement, which led to an insufficient dehydrogenation heat treatment, the forged shell showed a large number of hydrogen flakes in the center part of the forging.

The thickness of the VB395 forged shell is comparable to the Doel 3 and Tihange 2 RPV shells (maximum 264 mm), though it has a slightly smaller internal diameter (3,564 mm). Because of its hydrogen flaking, the block has been used as a reference.

Figure 4.18 The VB395 forged shell

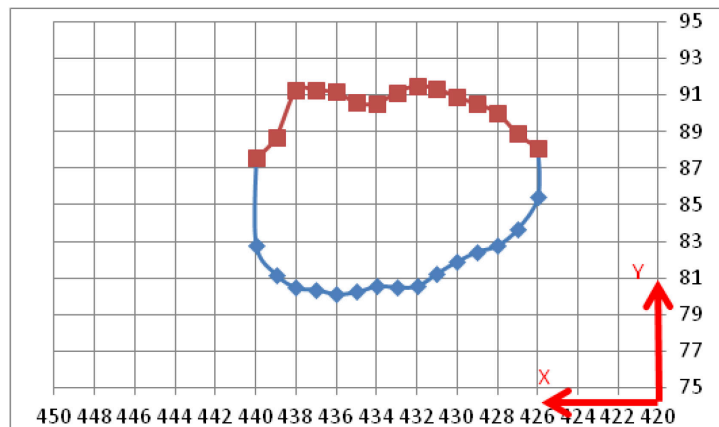
Some flakes were precisely measured and characterized by destructive measurements: 18 indications were cut, 12 of them are isolated indications and 6 correspond to 3 groups of 2 indications. The main findings, which confirm the modelling assumptions made in the structural integrity analyses, are:

- Most hydrogen flakes are laminar with a maximum inclination of 14° .
- The 3 groups of two successive indications were chosen to evaluate the ligament between them along the different axes. For those 3 cases, the results of the cuttings confirm the ultrasonic conclusions and the existence of this ligament.
- The material is perfectly sound between the successive hydrogen flakes.

Figure 4.19 The typical shape of a hydrogen flake established by destructive measurements

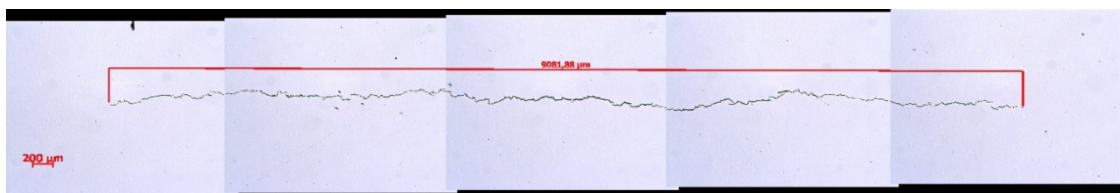
Figure 4.20 This figure shows a typical cross-section of the flake (9,081.88 µm)

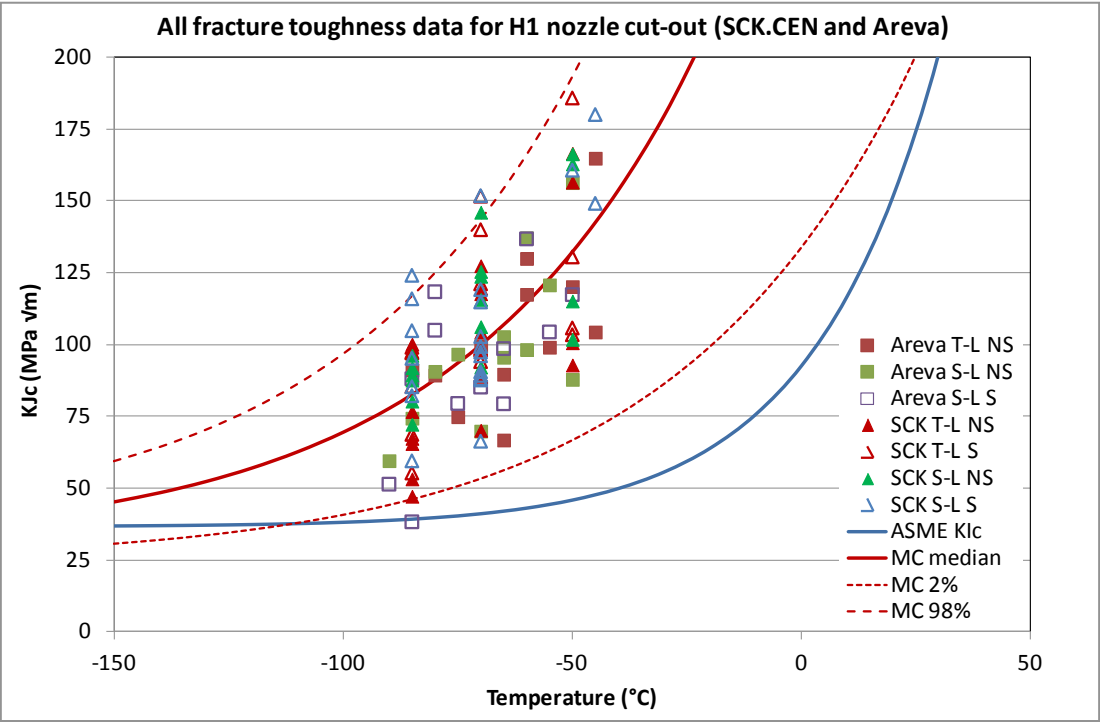
The results (see Table 4.4 and Figure 4.27) show that there is no difference between specimens sampled in the laminar orientation (propagation of a laminar defect in a plane parallel to the vessel surface) in the segregated zone and outside of the segregated zone. The difference does not exceed the usual experimental scatter in T_0 temperature. Similar results were obtained in the perpendicular orientation on the Doel 3 cut-out.

Figure 4.27 all fracture toughness test results from the nozzle cut-out of Doel 3, showing that all specimens can be considered as belonging to a same population

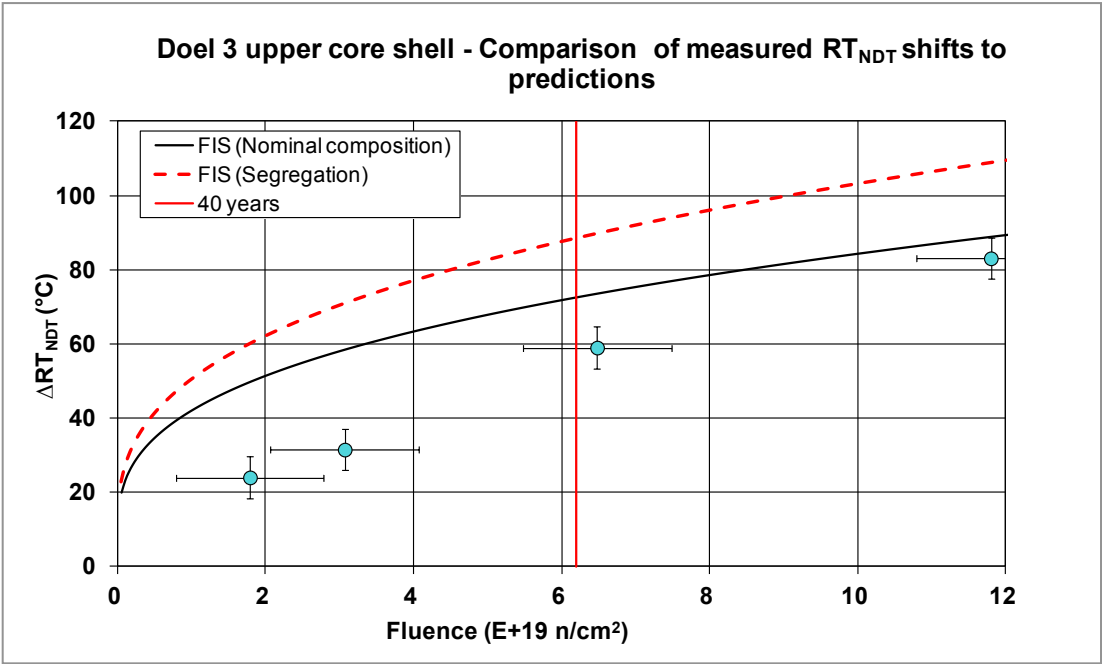
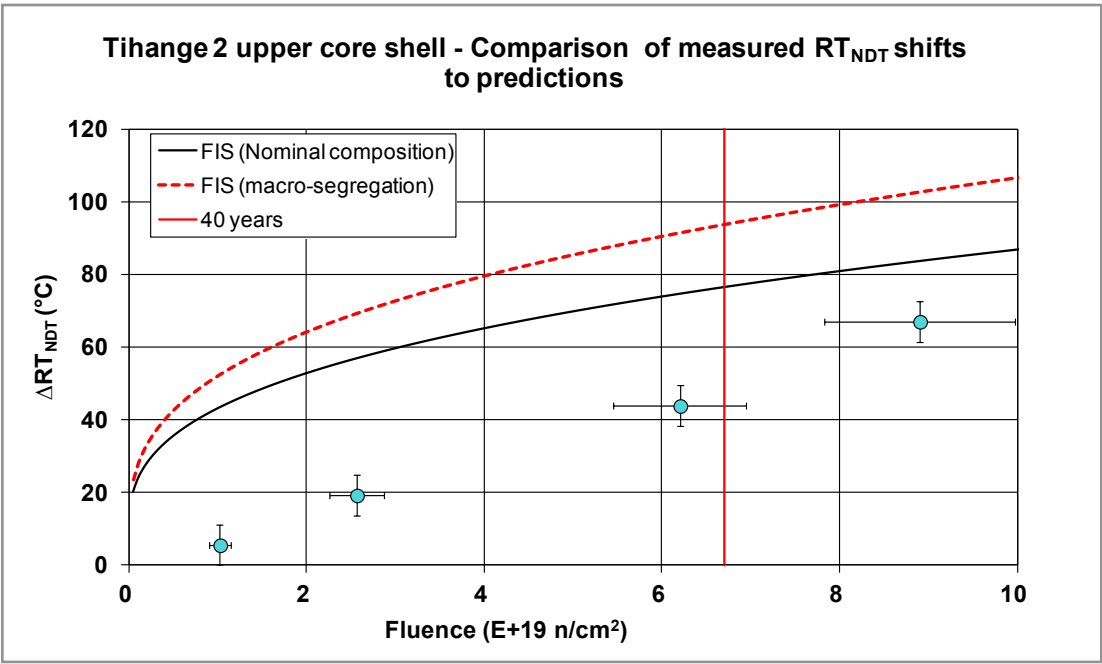
The 4 surveillance capsules initially in reactor have all been withdrawn from Tihange 2 and Doel 3. Experimental results are available for a fluence corresponding to at least 60 years of operation (the fluence at 40 years is $6.2 \cdot 10^{19} \text{ n/cm}^2$ in Doel 3 and $6.7 \cdot 10^{19} \text{ n/cm}^2$ in Tihange 2). They are illustrated by Figure 4.29 and Figure 4.30 below, where they are compared to the FIS predictive formula.

The FIS formula predicts the irradiation embrittlement on the basis of the copper, nickel and phosphorus content and of the neutron fluence. It was developed for the French RPVs, very similar to Doel 3 and Tihange 2 in terms of composition. In both cases, the FIS prediction is conservative, for example, a minimum of 10°C difference for forty years of operation (again, see Figure 4.29 and Figure 4.30, full lines).

The effect on the FIS predictions is illustrated in Figure 4.29 and Figure 4.30 (red dashed line) for Doel 3 and Tihange 2 respectively.

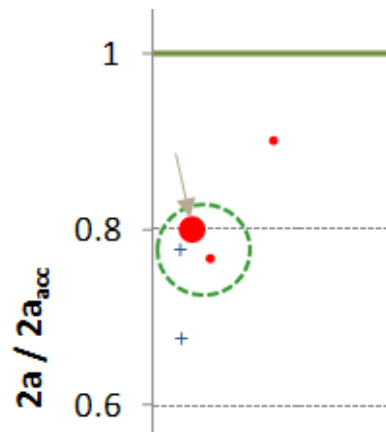
Detail from figure 4.41

In order to assess the conservativeness of the grouping methodology, a number of grouped flaws were ungrouped, and a 3D Finite Element analysis was performed covering all individual flaws in the group and their mutual interactions. A typical result of such an analysis for one of the grouped flaws of the lower core shell is given in the figure below. The illustration below shows that the 20 % margin of the grouped flaw increases to more than 70 % when considering a 3D analysis of the multiple flaw configuration.

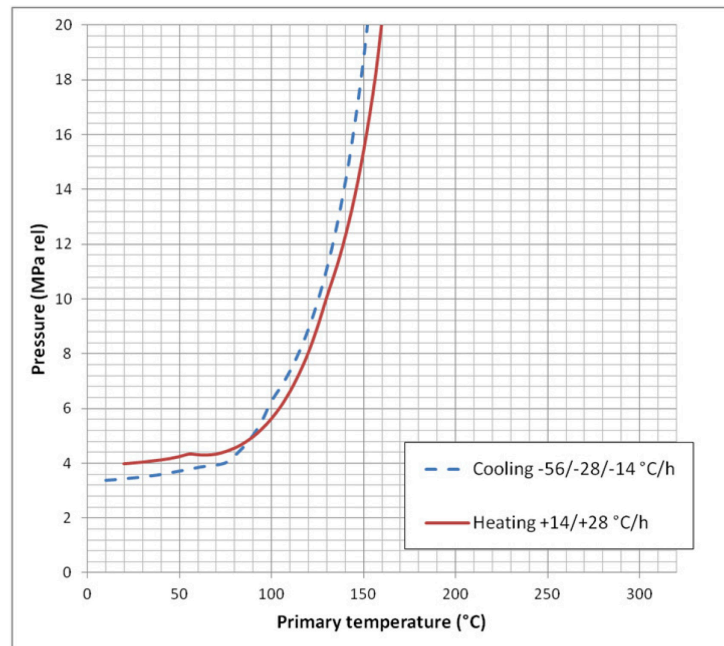
Figure 4.44 Updated p-T curves for Doel 3

The **p-T curves** are updated to include both the embrittlement of the RPV at the end of its service lifetime and the additional shift in RT_{NDT} of 50°C that covers the effect of macro-segregations on the fracture toughness.

The update of the p-T curves leads to more restrictive curves than those that are applicable today.
