SAFETY CASE 2015

# Tihange 2

## Reactor Pressure Vessel Assessment

28 10 2015

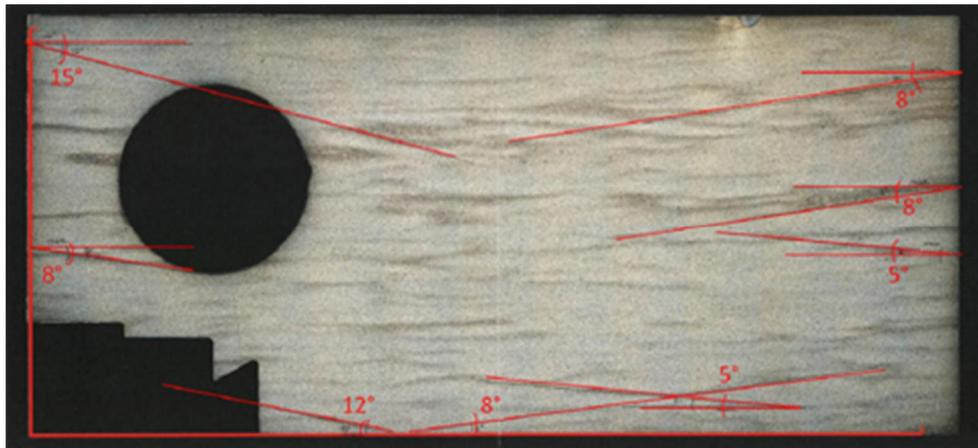
Figure 3.3: Example of inclination measurement (D3H1, axial direction).

The purpose of the examination was to measure the angle of the ghost lines that are the most susceptible to flaking (in macro-segregated areas, the darkest zones) and have the greatest inclination. Therefore, the test procedure consisted of identifying the areas with the most inclined ghost lines, taking micrographs of the selected areas (magnified by a factor 50), selecting the worst ghost lines on the micrographs and measuring the angles in axial and circumferential directions (Figure 3.3).

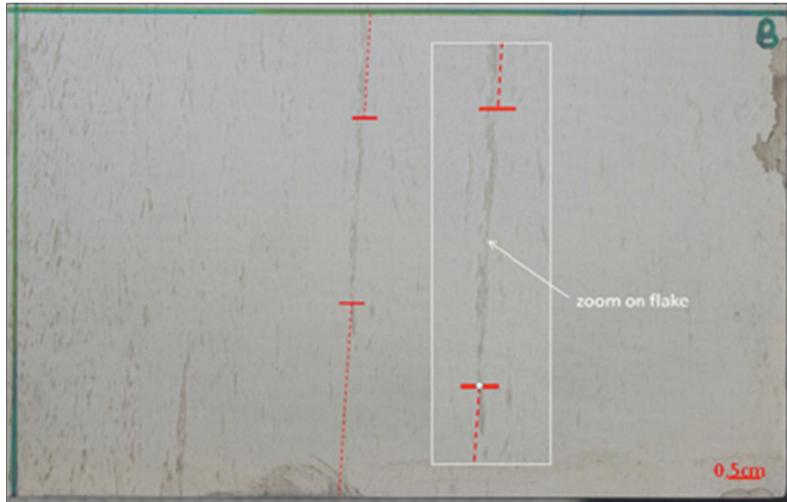
Figure 3.4: Detail of inclination measurement (VB395/1, axial direction).

The global inclination of the flakes was measured by drawing the line that connects the two end points (Figure 3.4).

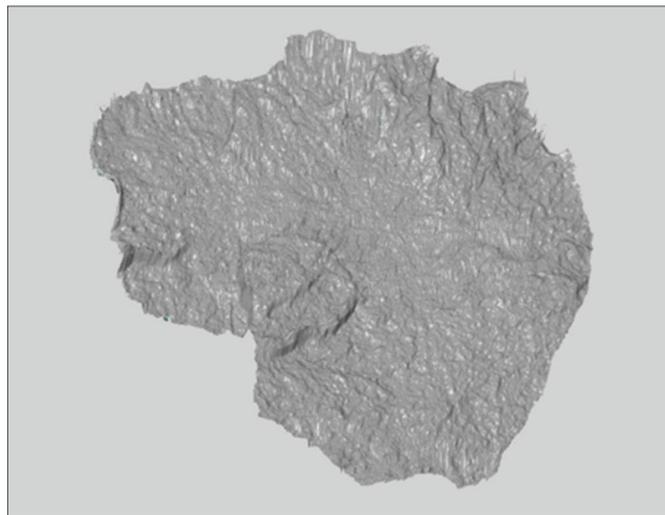
Figure 3.5: Typical flake appearance.

To get an accurate picture of the flakes' faceting (Figure 3.5), successive cross sections of the flakes were made, resulting in a series of crack profiles. These profiles were then superimposed and projected onto a single plane. This made it possible to estimate the degree of faceting. Finally, 3D profiling was applied.

- The observations confirmed that the flakes are located in ghost lines, primarily in those with the highest level of segregation.
- The flakes show multiple facets, both in the micro range (10 to 100  $\mu\text{m}$ ) and in the macro range (100 to 500  $\mu\text{m}$ ). No significant difference was found between the axial and circumferential directions.
- The characteristics of the KS 02 flakes are comparable to the characteristics of the VB395 flakes.
- The flakes were globally less inclined than the maximum angle of the ghost lines. They tend to remain laminar due to the influence of the forging's residual stresses.
- The maximum inclination of the ghost lines susceptible for flaking did not exceed 16° in both axial and circumferential directions.
- 15° is the maximum value expected for the flake inclination.

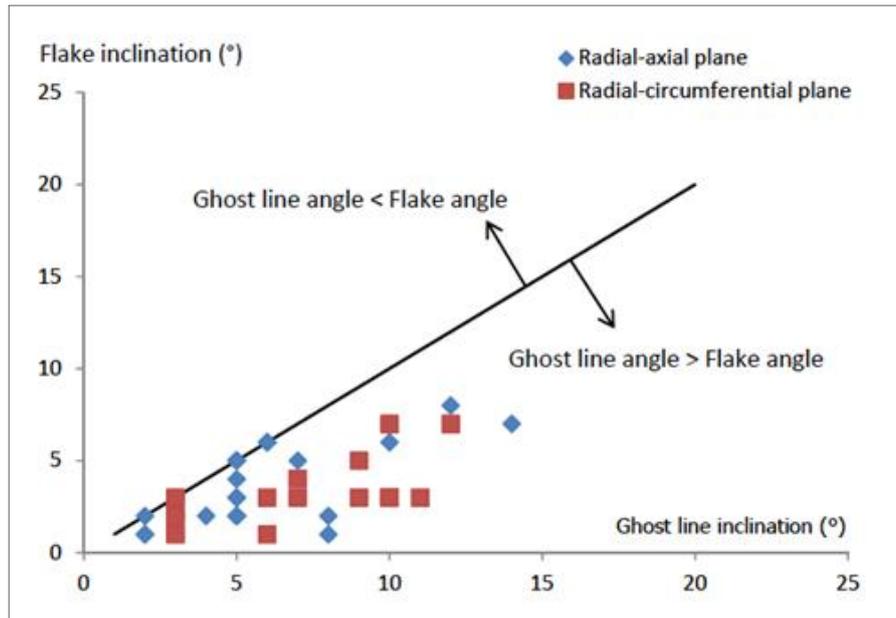
Figure 3.6: The flakes are systematically less inclined than the ghost lines (representative sample).

- The observations confirmed that the flakes are located in ghost lines, primarily in those with the highest level of segregation.
- The flakes tend to remain in the laminar direction even when the hosting ghost line deviates.
- The correlation between ghost line inclination and flake inclination was evaluated on several flakes. The average flake inclination is approximately  $4^\circ$  while the average ghost line inclination is approximately  $7^\circ$ . The investigation revealed that the flakes are systematically less inclined than the maximum ghost line inclination (Figure 3.6).

- The histograms of the maximum inclination measurements (worst ghost line angle distribution) are very similar for the three test blocks VB395/1, VB395/2 and D3H1.
- Among the 152 flake inclinations considered, only 5 flakes showed an inclination above 10° (3 with 11°, 1 with 12° and 1 with 15°). The mean value was approximately 4°.
- This value resulted from observations on a significant number of samples: 120 ghost line angles in D3H1, 495 ghost line angles and 152 flake angles in the two VB395 test blocks.

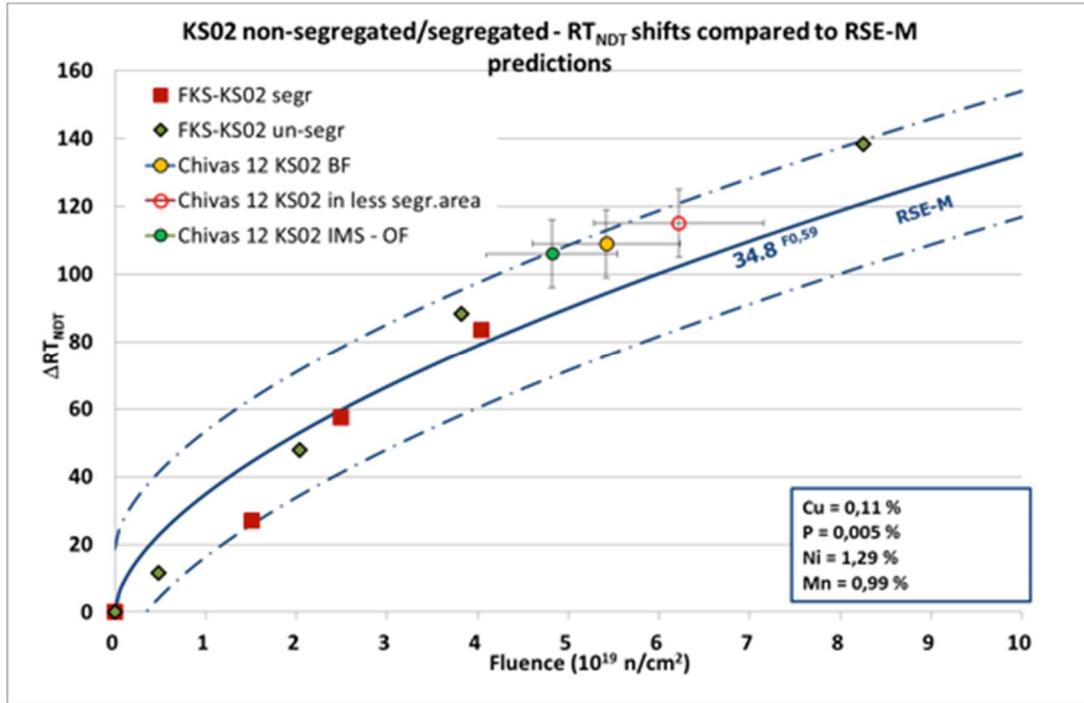
Figure 5.16: Measured shifts of  $RT_{NDT}$  for KS 02.

- The shifts of  $RT_{NDT}$  for specimens taken from non-segregated and segregated areas, and from both segments, fall practically on the same upper bound RSE-M trend curve (Figure 5.16) (although not strictly applicable to this material due to its high Ni content).

- The KS 02 results confirm that there is no specific sensitivity of this material to irradiation embrittlement due to the presence of hydrogen flakes.

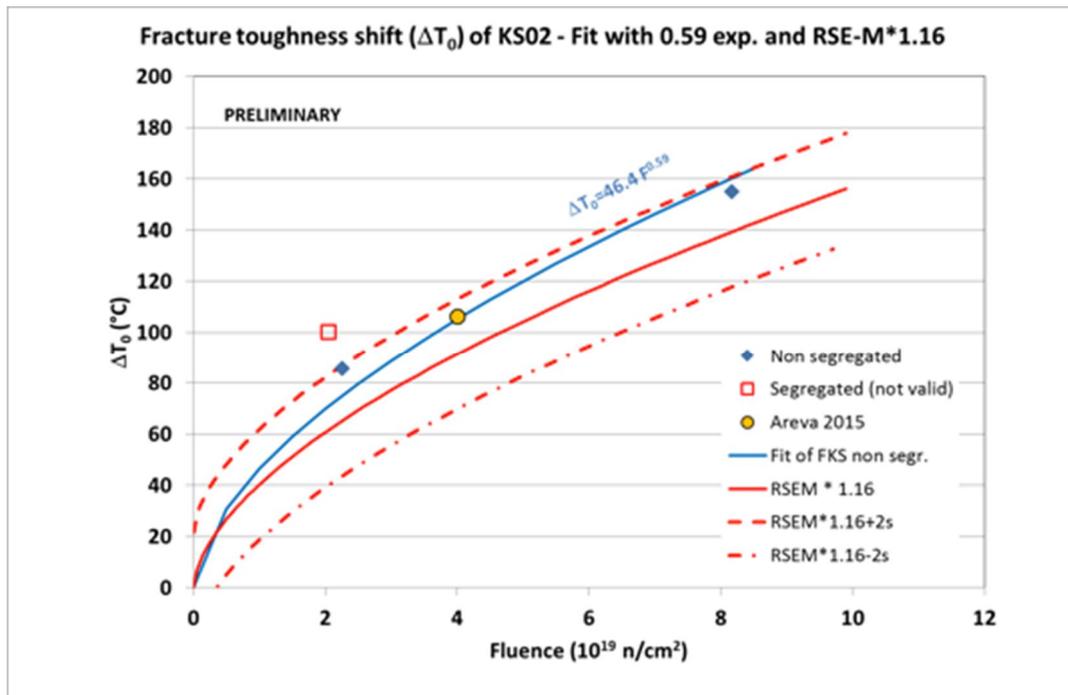
Figure 5.17: Measured shifts of  $T_0$  for KS 02.

- As can be seen in Figure 5.17, the  $T_0$  shift for specimens from the segregated zone is on the power law curve fitted through the existing results for the non-segregated area.

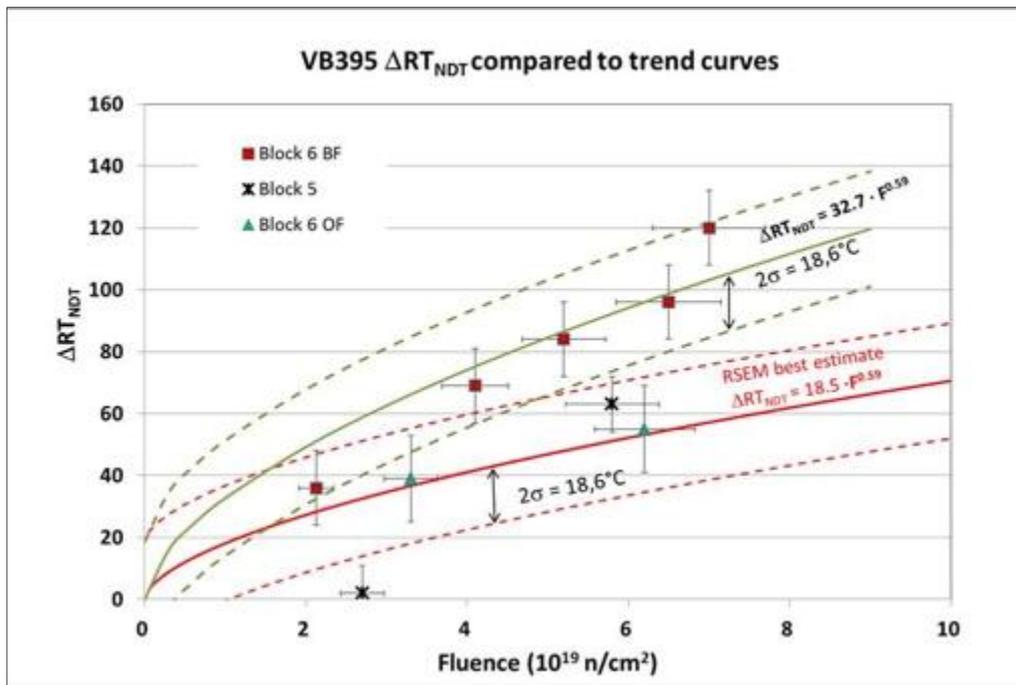
Figure 5.18: Measured shifts in  $RT_{NDT}$  for VB395.

- The  $T_0$  shift is largely above predictions.
- The  $RT_{NDT}$  shift in specimens taken between flakes is above the trend curve predictions but to a lesser extent than the fracture toughness (Figure 5.18).

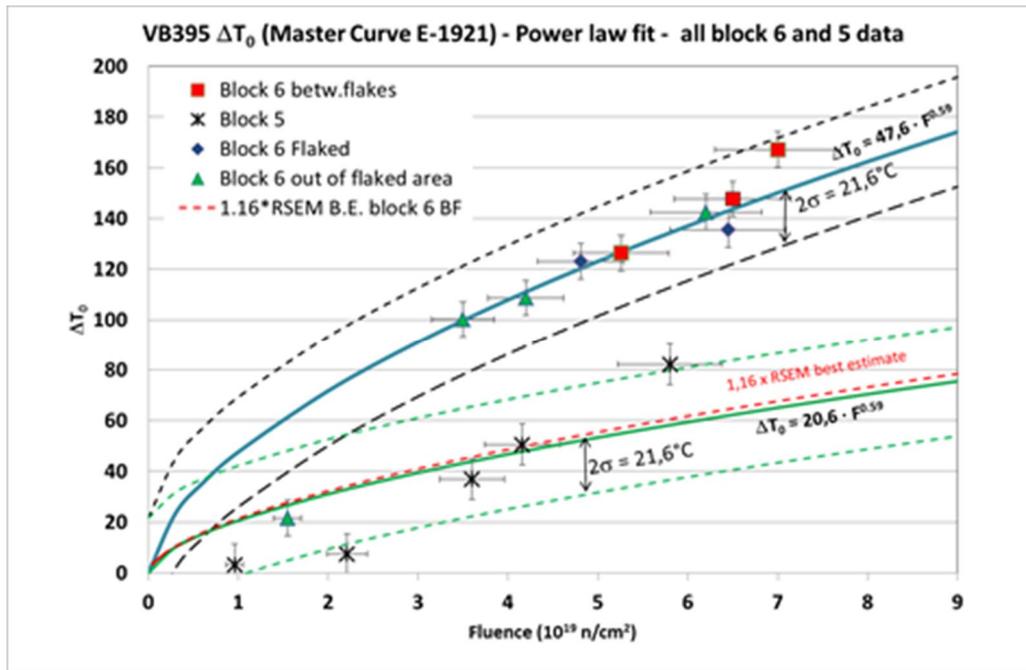
Figure 5.19: Measured shifts in  $T_0$  for VB395.

- As shown in Figure 5.19, specimens between flakes and with flakes follow the same  $T_0$  trend curve confirming the finding under non-irradiated conditions that the presence of hydrogen flakes does not cause a specific sensitivity to irradiation embrittlement. This observation is further confirmed through ductile fracture resistance tests performed on specimens taken between flakes and with flakes as crack initiator.

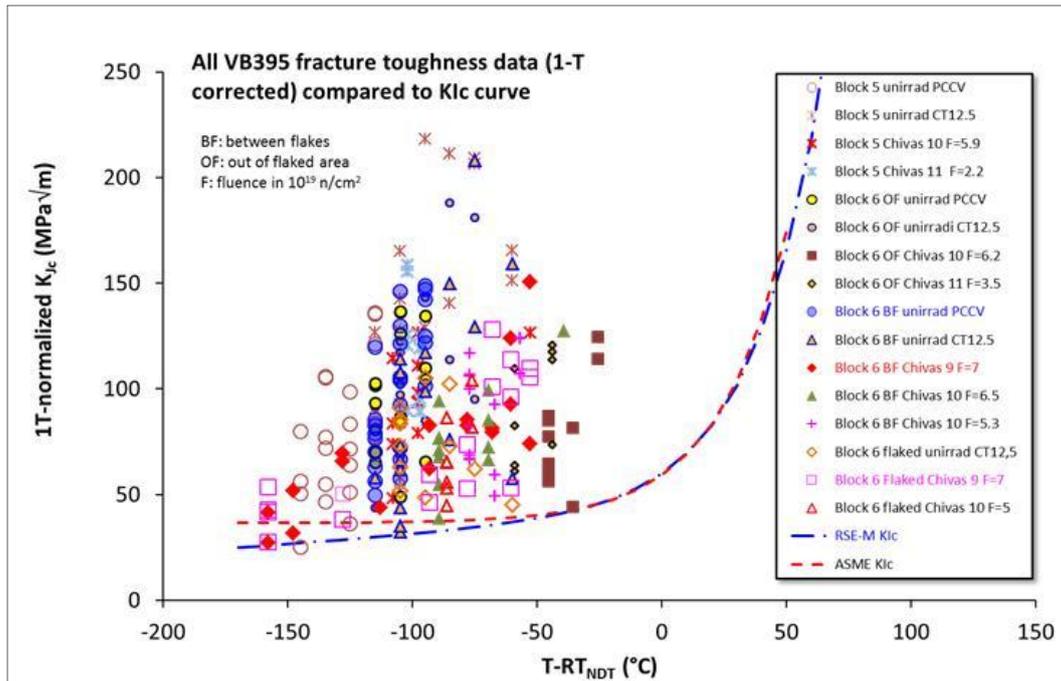
Figure 5.20: All fracture toughness results for VB395 materials compared to RSE-M and ASME  $K_{Ic}$  curves.

- Nevertheless, all fracture toughness results for VB395 remain enveloped by the RSE-M (Ed. 2010) and ASME  $K_{Ic}$  curves indexed to  $T-RT_{NDT}$ , as shown in Figure 5.20.

- Although there is a high shift of the fracture toughness curve under irradiation, there is no indication of a decrease of the lower shelf of the fracture toughness curves.

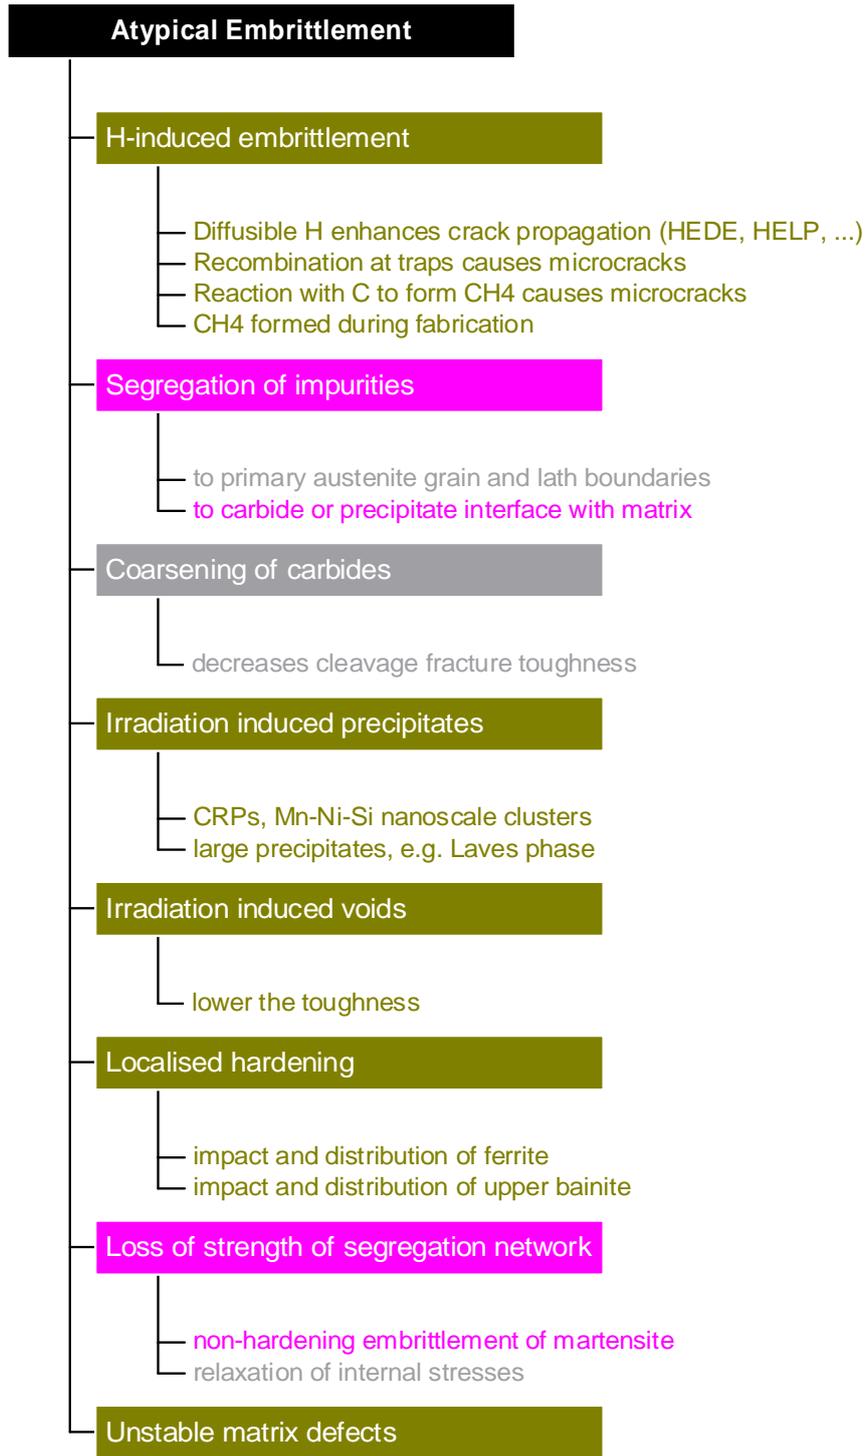
Figure 5.22: List of potential VB395 atypical embrittlement mechanisms after plausibility analysis.

All considered mechanisms have been qualified as excluded, unlikely or possible. The results are the following (Figure 5.22):

A strongly marked segregation network containing tempered martensite is present in VB395, whereas this network is much less visible and contains much less tempered martensite in D3T2. Literature shows that this type of microstructure is particularly sensitive to irradiation embrittlement due to enhanced diffusion of P in martensite. As shown above, VB395 could be susceptible to segregation of impurities.

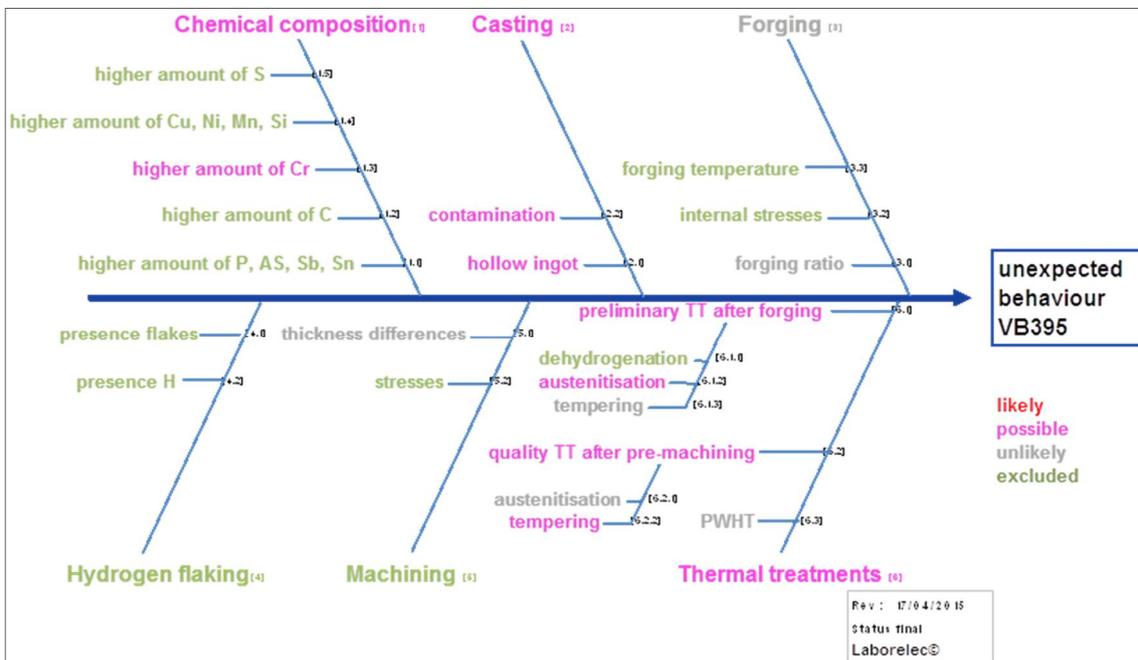
Figure 5.23: Fishbone diagram with colour-coded root causes.

Figure 5.23 shows the classification of the specific aspects of the manufacturing history of VB395 according to their plausibility. Possible root causes were identified in three domains: chemical composition, casting technique and thermal treatment. These causes can be linked with the possible mechanisms identified in the mechanistic approach:

- The higher amount of Cr of VB395, caused by contamination during the casting process, could have an influence on the P segregation and formation of carbides, as well as on the hardenability of the steel (contributing to a higher amount of tempered martensite). This is directly linked to both remaining possible mechanisms.
- The different casting procedure of VB395 can have an influence on the macro- and micro-segregations and the presence of a micro-segregation network. This is directly linked to the second remaining possible mechanism (loss of strength of segregation network).
- The deviating thermal treatments of VB395 can have an influence on the microstructure of the component (proportion of martensite, bainite, ferrite as well as formation, composition and coalescence of carbides). This is directly linked to both remaining possible mechanisms.

- Both mechanisms might be linked to specific aspects of the manufacturing history of the rejected VB395 shell that were evaluated as being possible root causes. These aspects are related to chemical composition, casting technique and thermal treatment.

- Since the larger than predicted shift in transition temperature after irradiation of VB395 is not linked with the hydrogen flaking and since none of the above mentioned manufacturing specificities are reported for the D3T2 RPVs, it is expected the D3T2 RPV shells do not suffer from the atypical embrittlement observed on VB395.

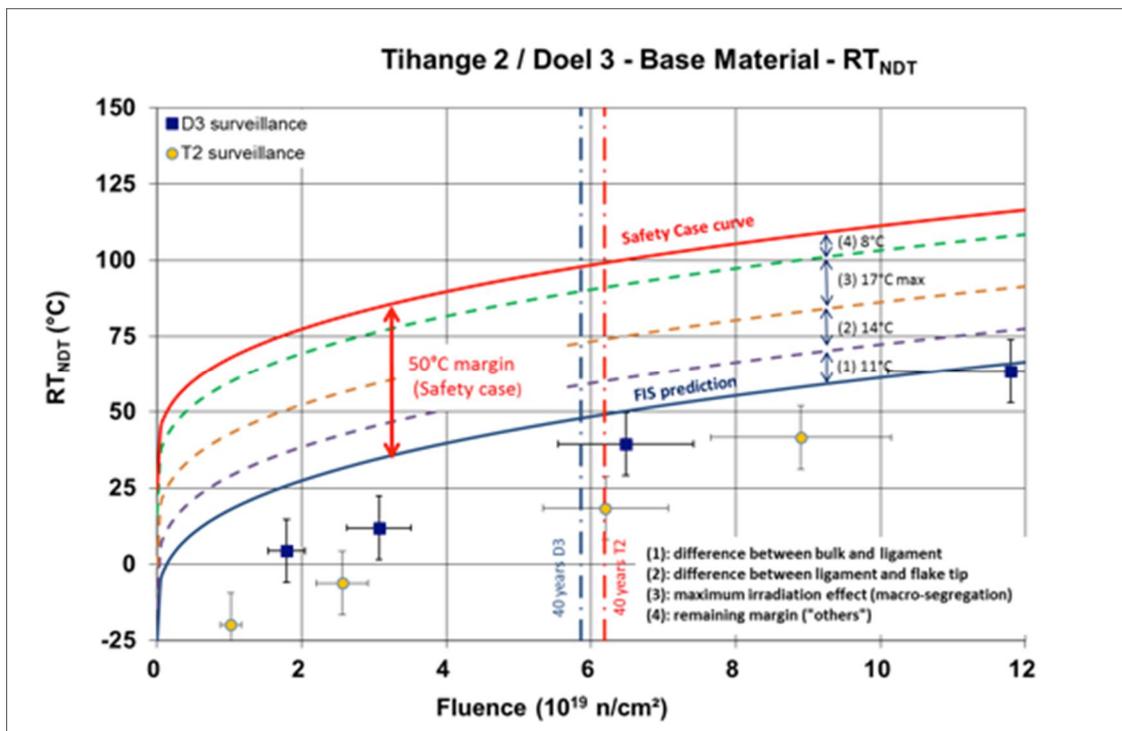
Figure 5.24: Trend curve  $RT_{NDT}$  as a function of fluence considered in 2012 Safety Case.

The SIA of the Tihange 2 RPV included in the 2012 Safety Case was performed on the basis of the  $RT_{NDT}$  versus fluence trend curve given in Figure 5.24. This trend curve was constructed starting from the French FIS embrittlement trend curve evaluated for the D3T2 core shell chemical composition, with an additional shift of 50°C to take into account the effects of orientation, segregation and irradiation sensitivity of the segregated zone.

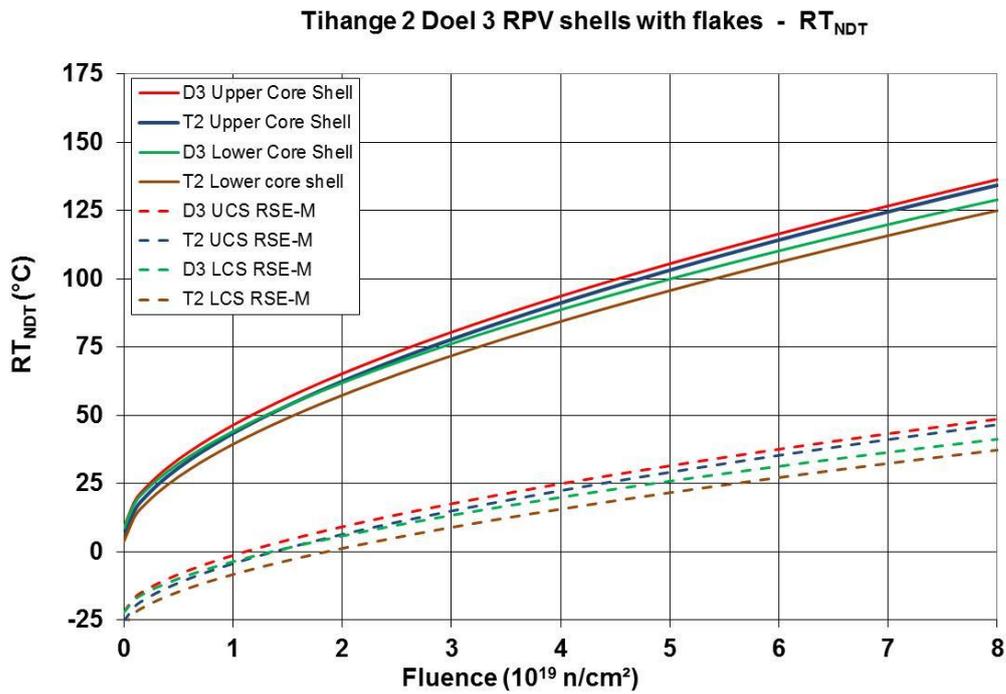
Figure 5.25:  $RT_{NDT}$  trend curves for the D3T2 core shells.

- $\Delta RT_{NDT,VB395}$  is an additional fluence dependent shift as observed on the VB395 material. It is taken as the difference between the observed atypical embrittlement of the material between hydrogen flakes and the embrittlement that can be expected for this material on the basis of the RSE-M trend curve

It should be pointed out that these trend curves are very conservative because they are based on the assumption that the D3T2 RPV core shells have an additional sensitivity to irradiation embrittlement of the same magnitude as the VB395 material, which is very unlikely taking into account the results of the test programme and the assessment of the atypical embrittlement of VB395.

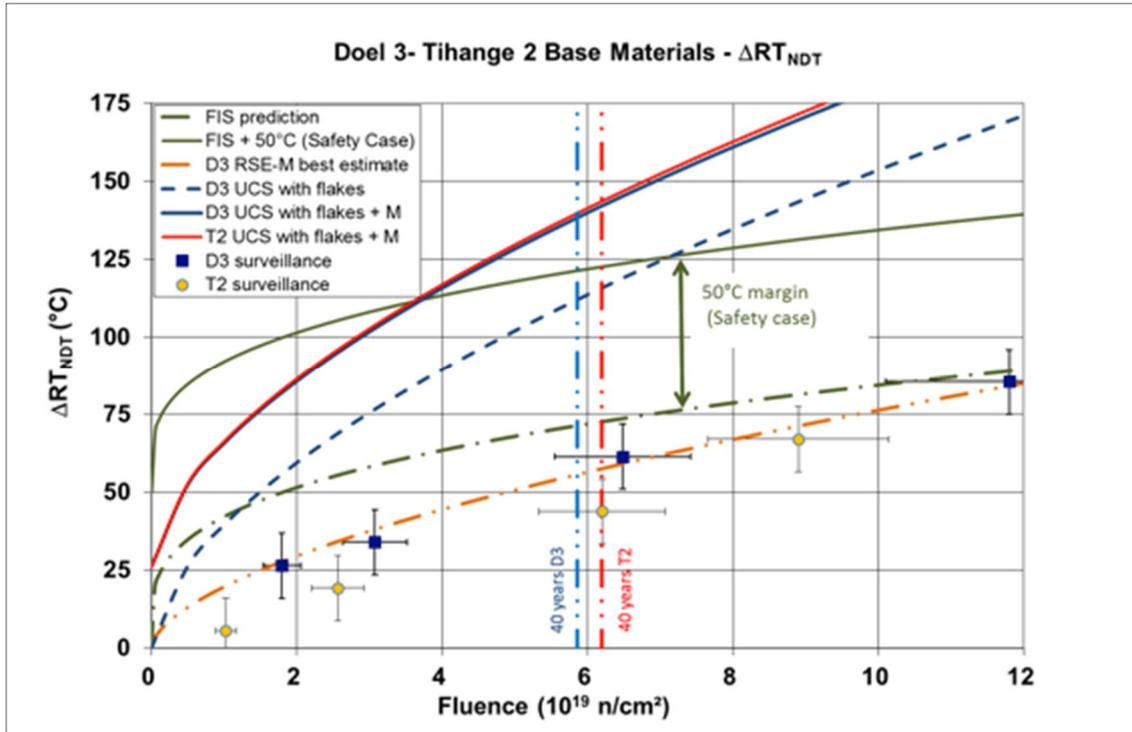
Figure 5.26:  $\Delta RT_{NDT}$  for flaked D3T2 upper core shells as a function of fluence.

As an example of the curves used in the SIA, the total  $\Delta RT_{NDT}$  (including the margin M) considered for the D3T2 upper core shells is given by the full blue and red curves of Figure 5.26. In this figure, a comparison is included with the trend curve considered in the 2012 Safety Case and with the results from the D3T2 RPV Surveillance Programme.

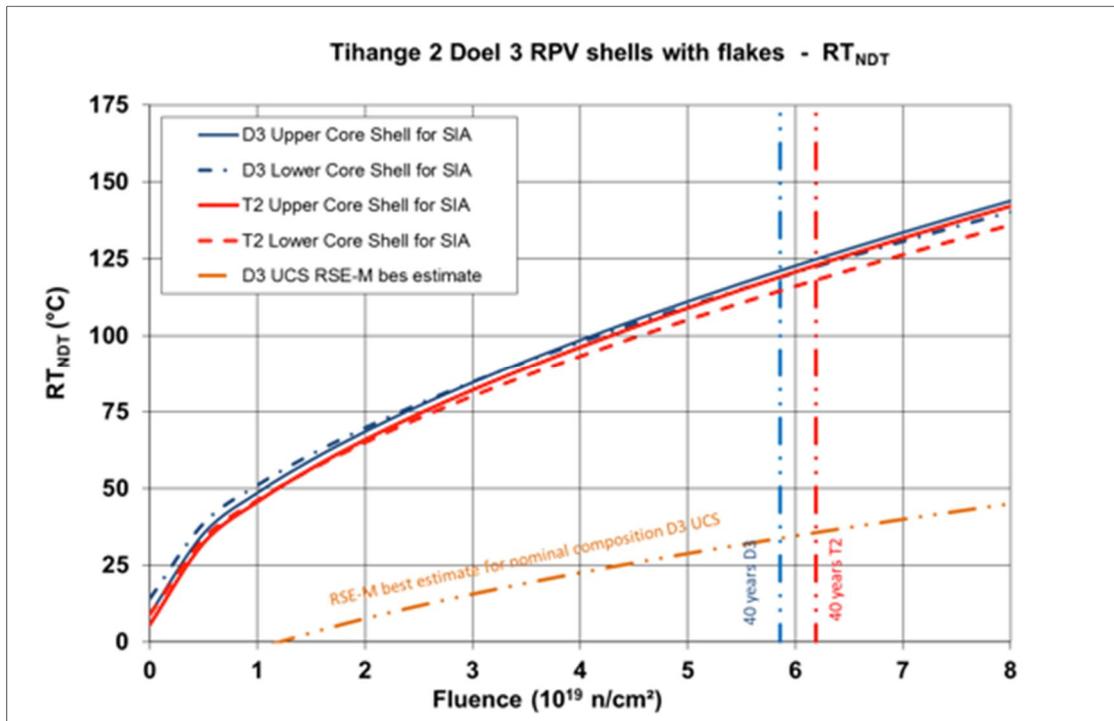
Figure 5.27:  $RT_{NDT}$  trend curves for the D3T2 core shells used in the SIA.

The final  $RT_{NDT}$  values to be considered for the four D3T2 core shells as a function of fluence are given in Figure 5.27. This figure also shows the expected maximum fluence values in the RPVs after 40 years of operation.

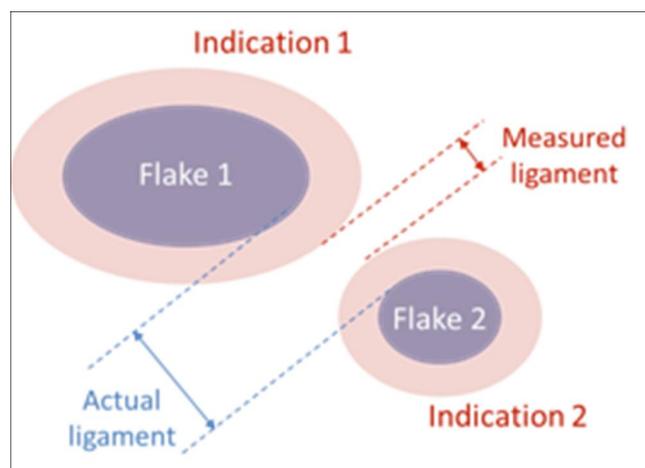
Figure 6.21: Undersizing the sound metal ligament between two oversized neighbouring flaws.

The overall tendency of the flaw sizing procedure is to overestimate actual flaw dimensions. This has been highlighted during the UT qualification exercise with flakes cut from block VB395/2A and subjected to detailed destructive examination (C1). Moreover, the size of small flakes is increased up to the beam size, before proceeding to structural integrity calculations (C2). Consequently, oversizing neighbouring flaws leads to undersize the sound metal distance between them (Figure 6.21), or, should the flaws lie too close to be possibly discriminated, to report them as a single large indication (C3).

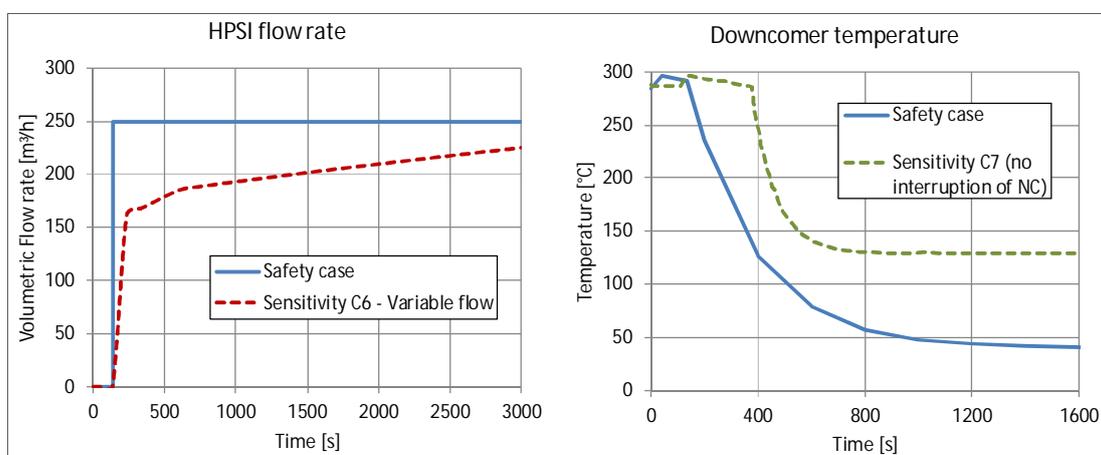
Figure 6.22: Conservative hypotheses C6 and C7 in the definition of Small Break LOCA transient.

The most stringent level C/D transient regarding the RPV structural integrity is the small break LOCA. In the Safety Case analysis of this transient, a constant High-Pressure Safety Injection (HPSI) flow rate is considered. This constant flow rate is equal to the run-out flow rate of the HPSI pump, i.e. the flow rate corresponding to a counterpressure of 1 bar abs (cf. Figure 6.22). This assumption is conservative as it does not account for the actual counterpressure during the transient (C6). Accounting for the actual counterpressure leads to a lower SI flow rate and thus to a lower downcomer cool-down rate and final temperature. In terms of structural integrity, this conservativeness is assessed on selected flaws from the Doel 3 RPV (with maximal  $2a/2a_{acc}$  and with the highest crack driving force) and leads to an overestimation of:

- The ratio to acceptable flaw size by 5% (for the highest  $2a/2a_{acc}$  flaw).
- The maximum crack driving force by 7% (for the highest  $K_{J,MAX}$  flaw).

On the other hand, a complete interruption of the circulation flow rate (be it forced or natural) in the primary loops is considered during the entire small break LOCA transient (C7). As a consequence no mixing occurs between the relatively hot water coming from the SGs and the relatively cold SI flow. The temperature of the water reaching the RPV downcomer is thus conservatively assumed to be equal to the relatively low SI temperature and this during the entire transient. This results in a high cool-down rate of the RPV downcomer wall leading to an overestimation (based on the same selected flaws from the Doel 3 RPV) of:

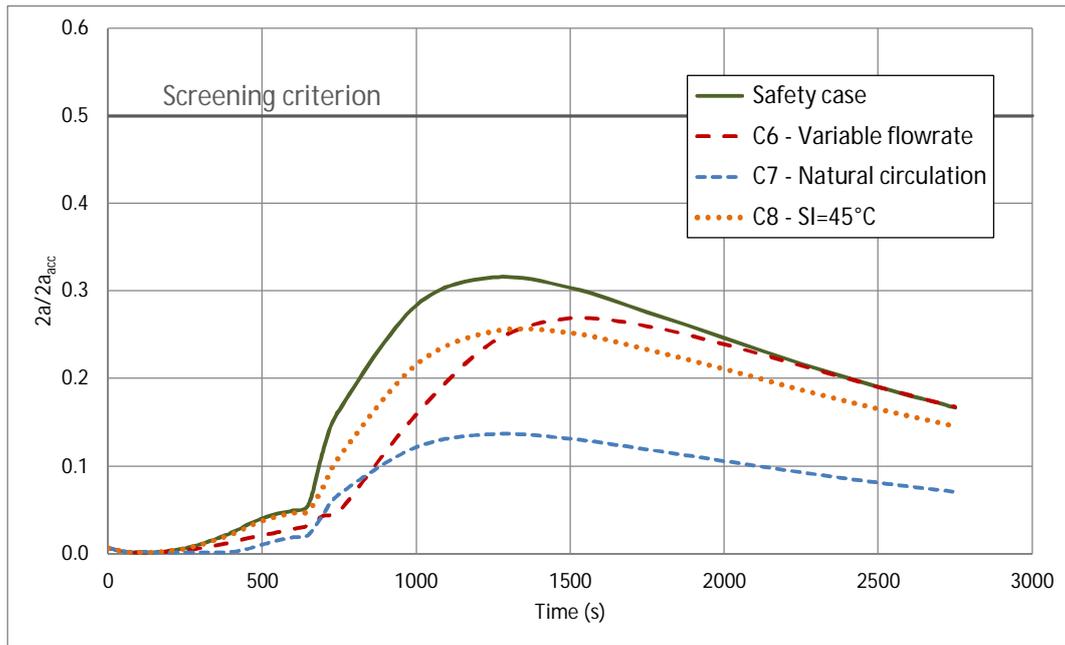
The small break LOCA is defined with a minimum SI temperature of 7°C at Tihange 2 (C8). However, when considering best-estimate temperatures (15°C at Tihange 2), calculations based on the flaws with maximal  $2a/2a_{acc}$  and with the highest crack driving force (from the Doel 3 and Tihange 2 RPVs) have shown additional margins:

- 7% on the ratio to acceptable flaw size (for the highest  $2a/2a_{acc}$  flaw).
- 4% on the maximum crack driving force (for the highest  $K_{J,MAX}$  flaw).

The conservativeness is illustrated in Figure 6.23 for an individual flaw close to the cladding-base metal interface.

Figure 6.23: Time evolution of the ratio to acceptable size of a flaw close to the cladding-base metal interface, for the different sensitivity analyses on the Small Break LOCA transient.

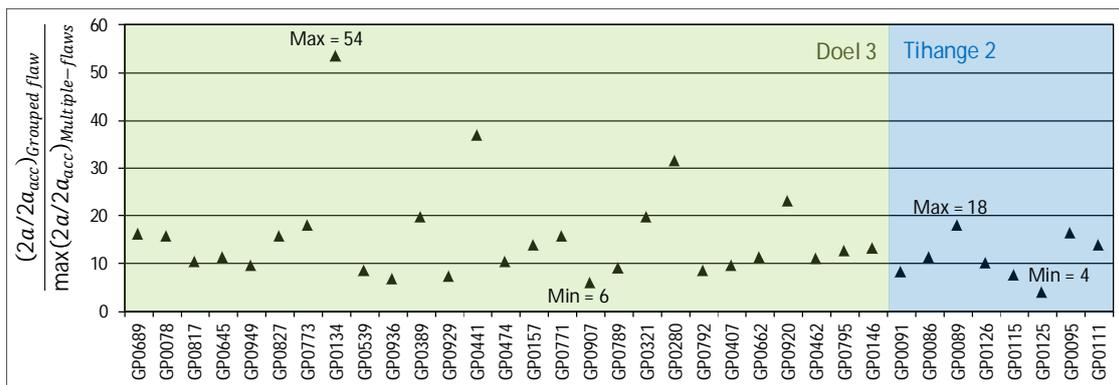
The conservativeness linked to the proximity rules (C9 and C10), to the grouped flaw definition (C11 and C12) and to the acceptable size calculation (C14) are together illustrated in Figure 6.24. This figure compares the ratio to acceptability before (grouped flaw) and after (multi-flaw) refined analysis.

For Tihange 2, the ratio  $2a/2a_{acc}$  of the grouped flaw is between 4 times and 18 times higher than the ratio  $2a/2a_{acc}$  calculated with refined analyses.

Figure 6.24: Impact of multiple-flaws analyses on  $2a/2a_{acc}$  for Doel 3 and Tihange 2 core shells.

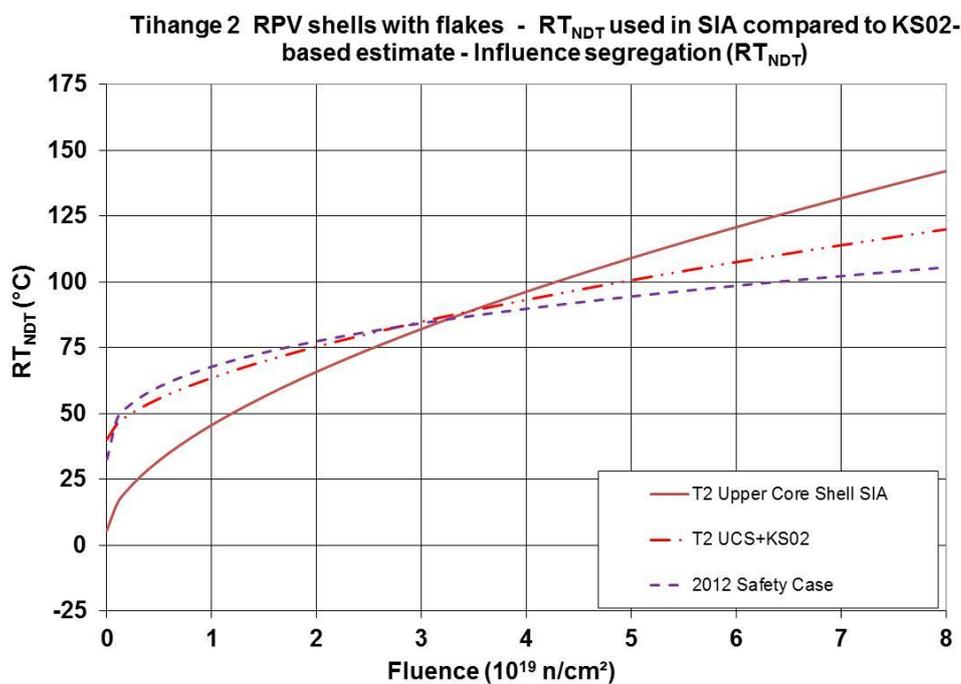
The curve of  $RT_{NDT}$  evolution vs. fluence for the KS 02-based approach for the upper core shell of Tihange 2 is compared in Figure 7.1 to the curve used in the SIAs in 2014-2015 as well as to the curve used in the initial Safety Case of 2012. The KS 02-based approach is close to the one of the 2012 Safety Case in the fluence range of interest (up to  $6 \cdot 10^{19} \text{ n/cm}^2$ ). It is more conservative than the VB395-based approach in the low fluence range (up to approximately  $3.4 \cdot 10^{19} \text{ n/cm}^2$ ) and less conservative above this value.

Figure 7.1:  $RT_{NDT}$  evolution with fluence considered in the 2014-2015 SIA compared to the curve of the initial Safety Case and to the alternative KS 02 based approach.
